# Pyongsan Uranium Concentrate Plant (Nam-chon Chemical Complex)

*Infrastructure Development and Status*

A Report of the CSIS KOREA CHAIR

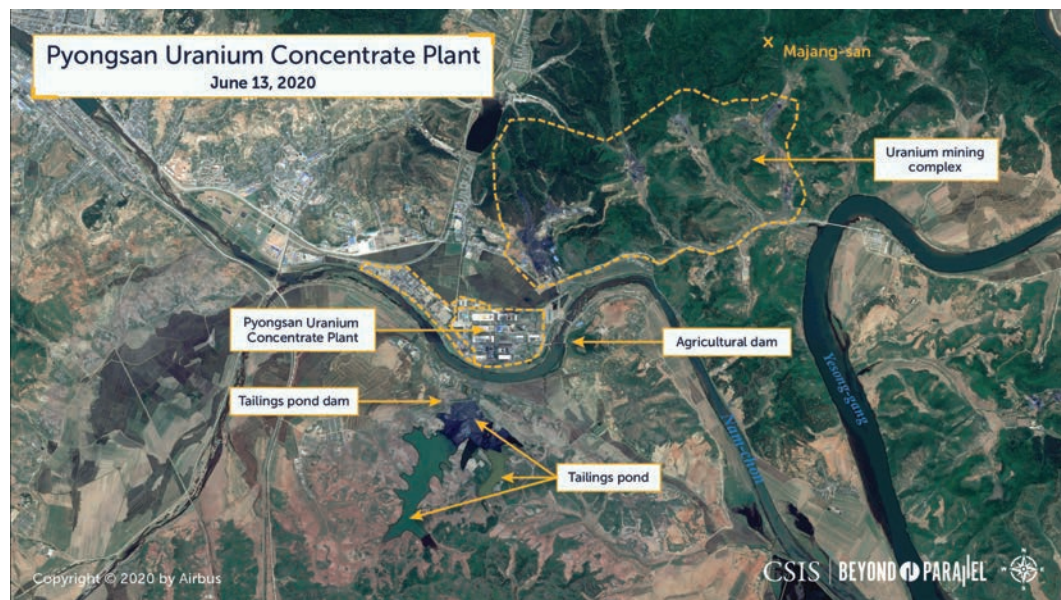
Slide 03: Overview Image of the Pyongsan Uranium Concentrate Plant, Tailings Pond, and January Industrial Mine (mining complex) - June 13, 2020 (Copyright © 2020 by Airbus)

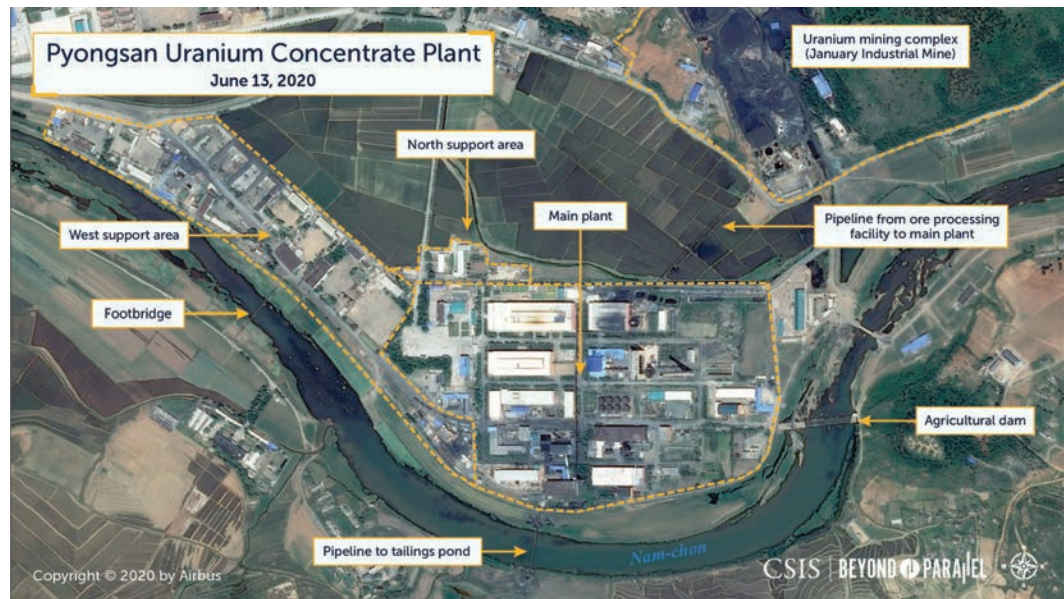
Slide 04: Overview Image of the main facility and support areas - June 13, 2020 (Copyright © 2020 by Airbus)

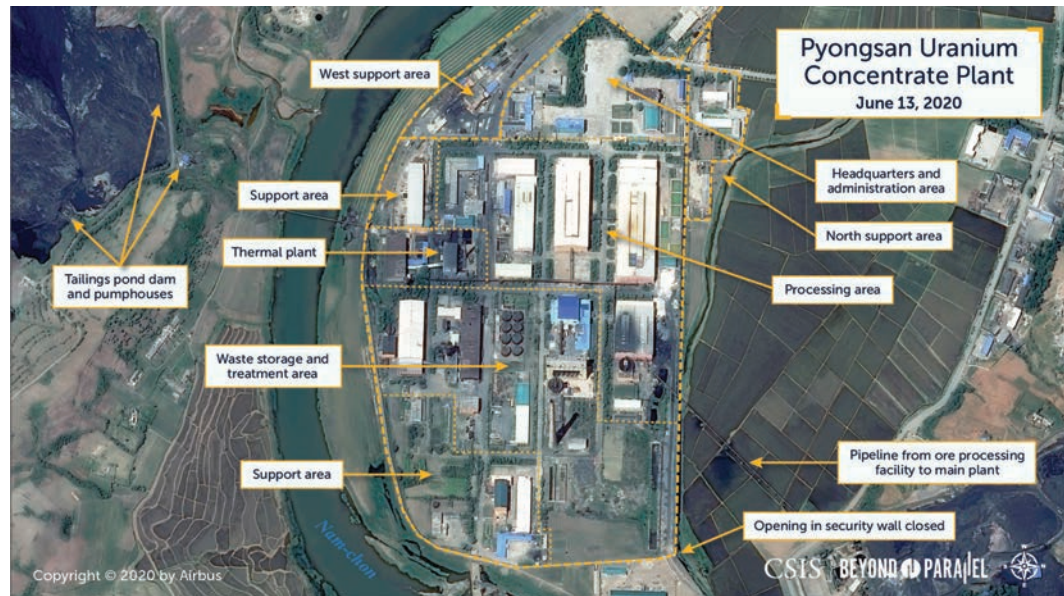
Slide 05: The main plant and north support area - June 13, 2020 (Copyright © 2020 by Airbus)

The headquarters and administration area is located on the northwest side of the main plant. It controls access to the main plant and consists of approximately 24 structures (including four greenhouses), a parking/parade area, and several monuments. Aside from typical headquarters and administration functions, this area likely houses security and engineering offices. With the exception of some minor construction, this area has

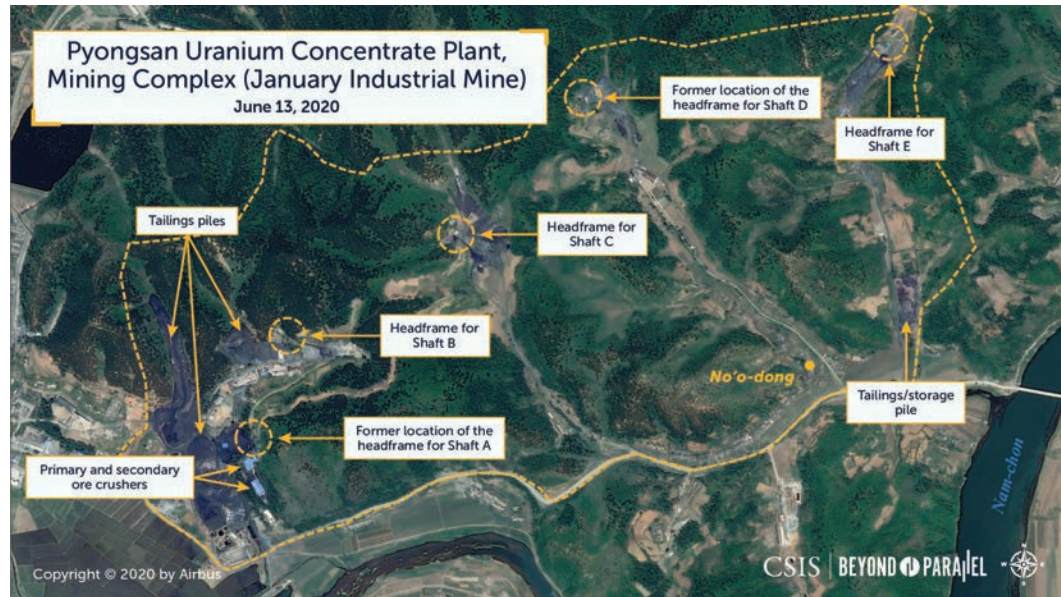
Slide 09: Overview of the mining complex (January Industrial Mine) - June 13, 2020 (Copyright © 2020 by Airbus)

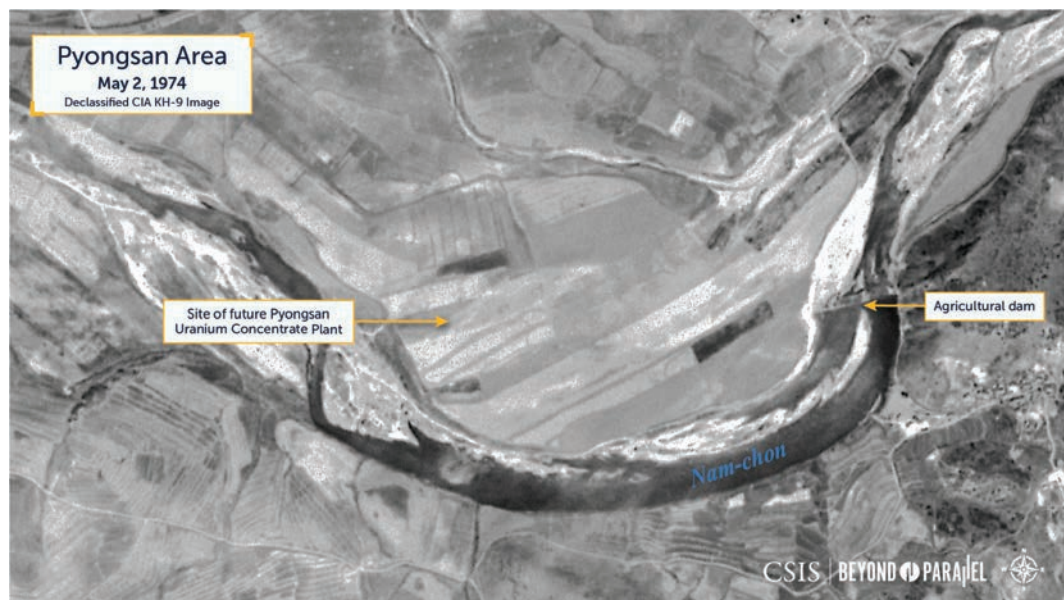
Slide 15: A declassified KH-9 satellite image from May 2, 1974, showing a closeup of the area where the main plant would be built and the adjacent agricultural dam. (CIA)

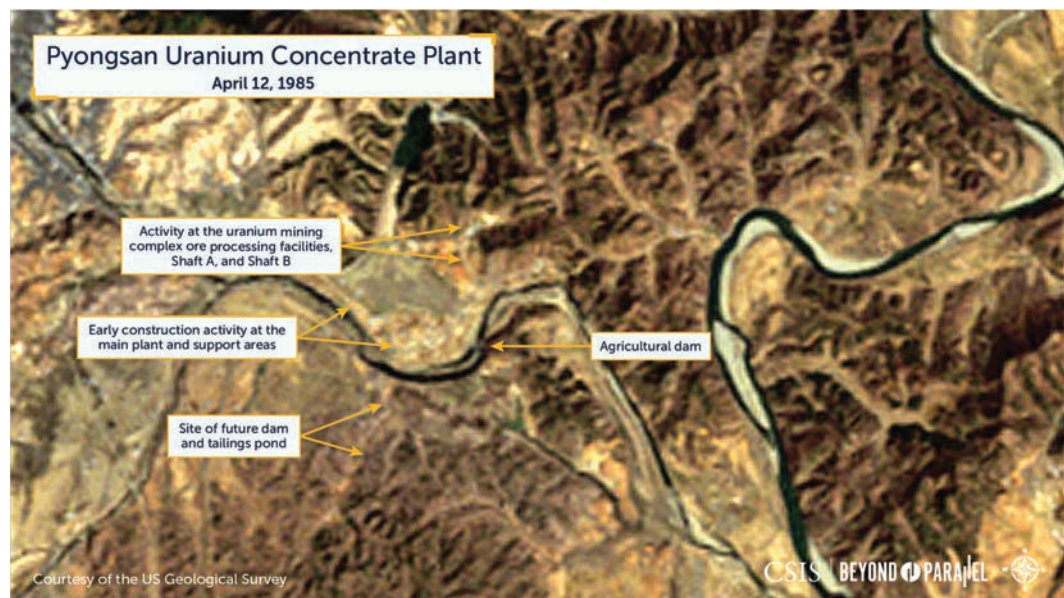
Slide 19: Although of medium resolution, a Landsat 5 image acquired on April 12, 1985, shows ground scarring from early construction activity at the main plant and mining complex. (USGS)

According to the Institute for National Unification's *Chronicle of the North Korean Nuclear Issue 1955-2009*, construction of the Pyongsan Uranium Concentrate Plant began on November 5, 1985. This assertion may be somewhat refined by a Landsat 5 image acquired on April 12, 1985, that appears to show ground scarring at the future sites of the Pyongsan Uranium Concentrate Plant, west support area, and the uranium mining complex.<sup>47</sup>

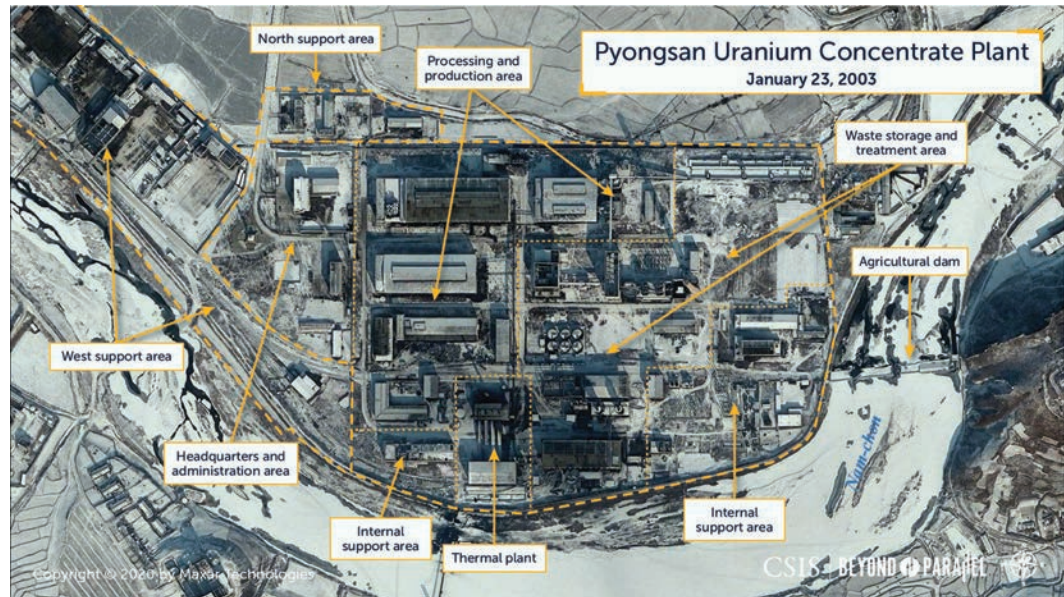
Slide 28: The functional areas of the main plant and north support facility, as well as the suspended pipeline to the tailings pond and the preexisting agricultural dam east of the plant - January 23, 2003 (Copyright © 2020 by MAXAR Technologies)

By January 2003, the main plant itself had reached its current size of approximately 24.2 hectares (most of which was enclosed within a security wall) and contained approximately 65-75 significant structures. As noted, until more detailed information becomes available, CSIS has provisionally separated the main plant into six functional areas: headquarters and administration, processing, waste storage and treatment, thermal plant, support, and railway.<sup>64</sup>

The processing area contained approximately 15 buildings. As noted, the conversion of uranium ore to yellowcake requires numerous processes, including the crushing and grinding of the ore, the addition of water to produce a slurry, and then the leaching of that slurry to extract the required uranium. Both the uranium-containing and waste solutions must be processed. Until more detailed information becomes available, the five largest buildings are provisionally identified as the grinding and sampling, leaching and classifying, solvent extraction and precipitation, and yellowcake production and packaging buildings. For example, ore is brought on-site from the adjacent mine via pipe where it feeds into the building identified by CSIS as the probable “sampling and grinding building.” In addition to being consistent with the initial processing of uranium ore, further confidence in this identification can be gained from the presence of black exhaust dust over the building. Notable within the area identified by CSIS as likely being involved with yellowcake production and packaging is a rail-served loading/unloading building.

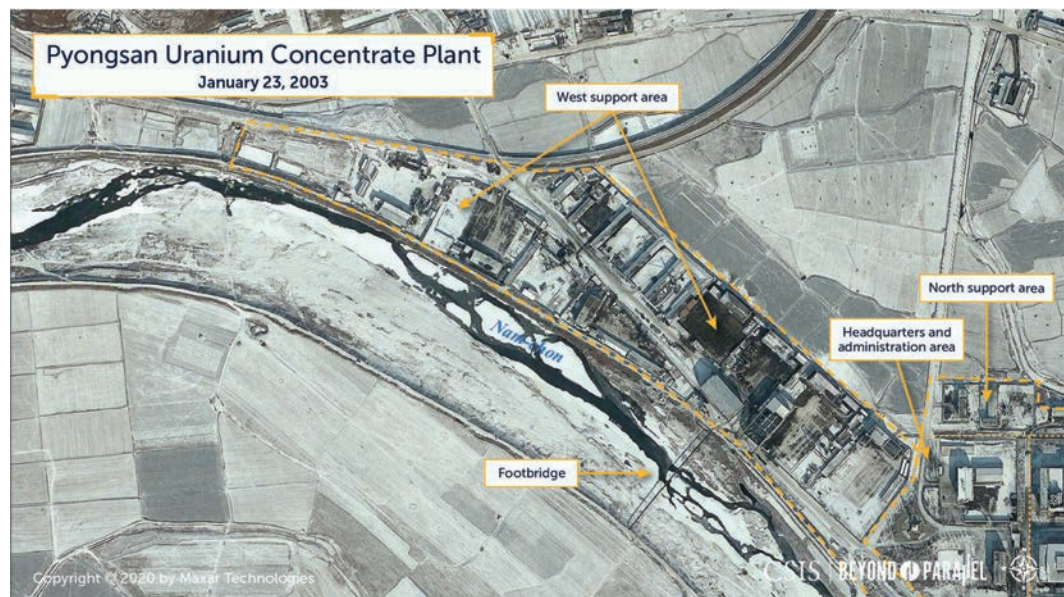
Slide 29: The west support area (including rail facilities) - January 23, 2003 (Copyright © 2020 by MAXAR Technologies)

The north support area encompassed approximately 1.1 hectares containing five buildings, including an electric substation, security office, and small support buildings. The west support area encompassed approximately 12.3 hectares with 35-40 buildings and was organized into a number of small activities (e.g., warehouses, open-air storage, vehicle maintenance and storage, foundry, etc.). The main plant and west support area share a small railyard that has dedicated but small locomotive and railcar servicing facilities and terminates in a three-track stub yard within the main plant.

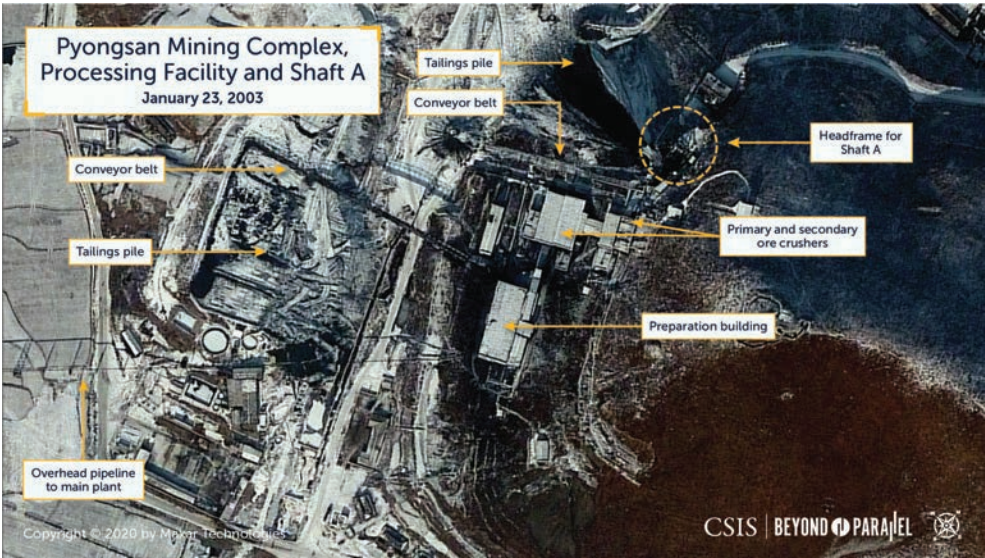
Slide 31: The mine's processing facilities, headframe at Shaft A, and associated tailings piles - January 23, 2003. (Copyright © 2020 by MAXAR Technologies)

Prior to 2003, the January Industrial Mine's activities, northeast of the main plant, expanded to approximately 235 hectares on the southern slopes of Majang-san. Within this space, the mining complex included five active vertical shaft mines, tailings piles, an ore processing facility, and a variety of smaller support activities around it. The ore processing facility (38.323407 N, 126.437758 E) consisted of primary and secondary crushers, an ore preparation building, and an approximately 515-meter-long pipeline connecting to the Pyongsan Uranium Concentrate Plant to transport crushed uranium ore (likely in a slurry form). All five mine shafts (identified for readability in this report as Shafts A-E) had headframes (i.e., the frame structure above the mine shaft used to raise and lower workers,

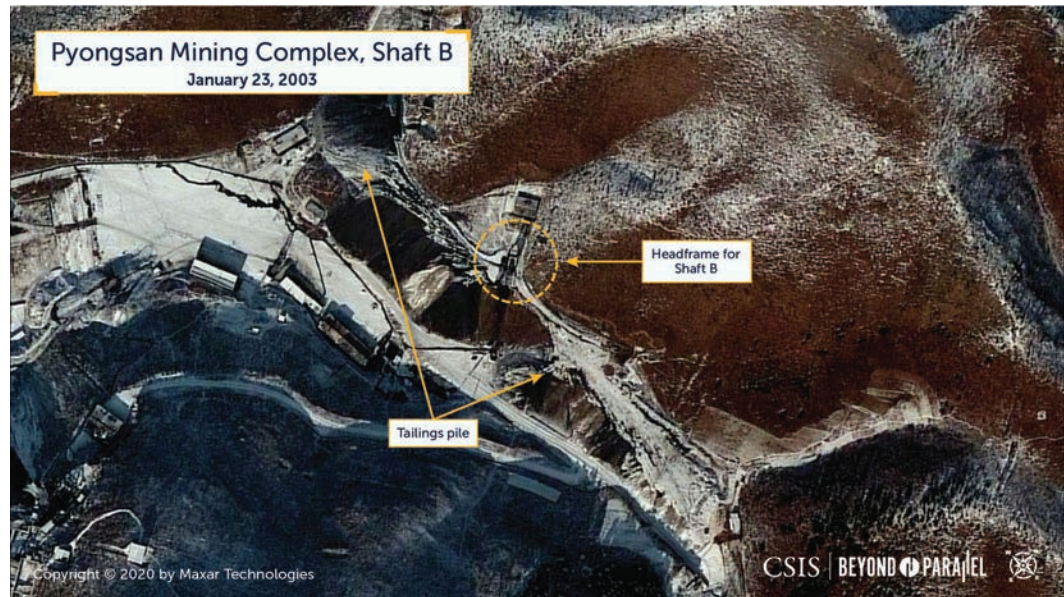
Slide 32: The headframe and tailings piles at Shaft B - January 23, 2003 (Copyright © 2020 by MAXAR Technologies)

- Shovels and trucks are often observed working on the tailings piles across most satellite images.
- Shaft B also began operations during the early-1980s and remained in operation until about late-2013 when it appears to have suspended operations. During 2003-2006, grading activity on the west side of the tailings pile suggested that there may have been a new mine shaft located here. Close examination of multiple satellite images, however, shows no evidence of either a vertical or horizontal mine shaft at this location. The activity observed was likely the result of grading or dragline operations to more completely fill the lower end of the small valley in which the tailings pile was located. As of April 2020, the Shaft B headframe remains in place, although the operations are either suspended or at low levels.

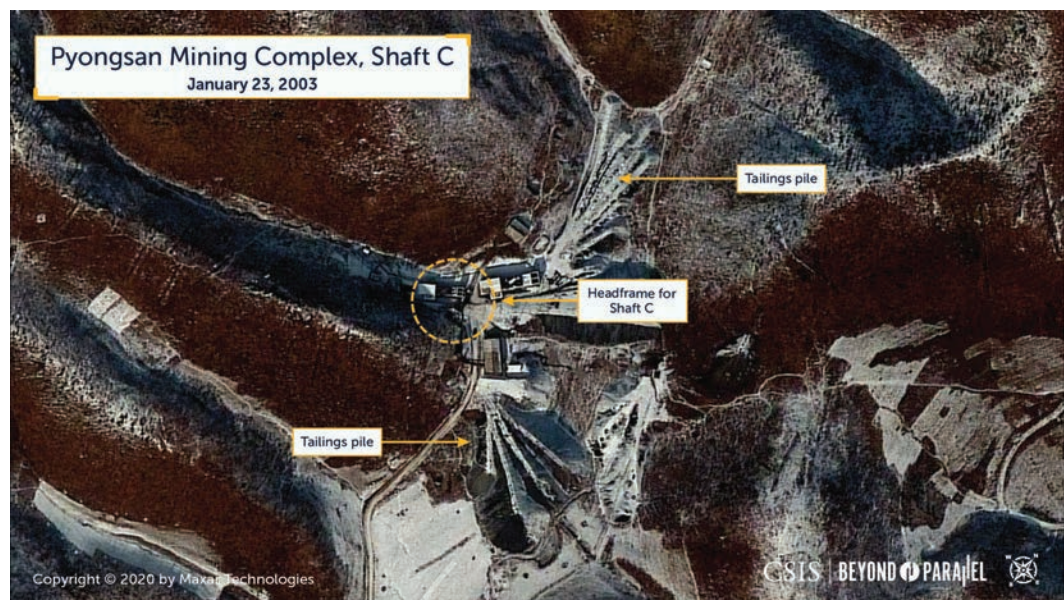
Slide 33: The headframe and tailings piles at Shaft C - January 23, 2003 (Copyright © 2020 by MAXAR Technologies)

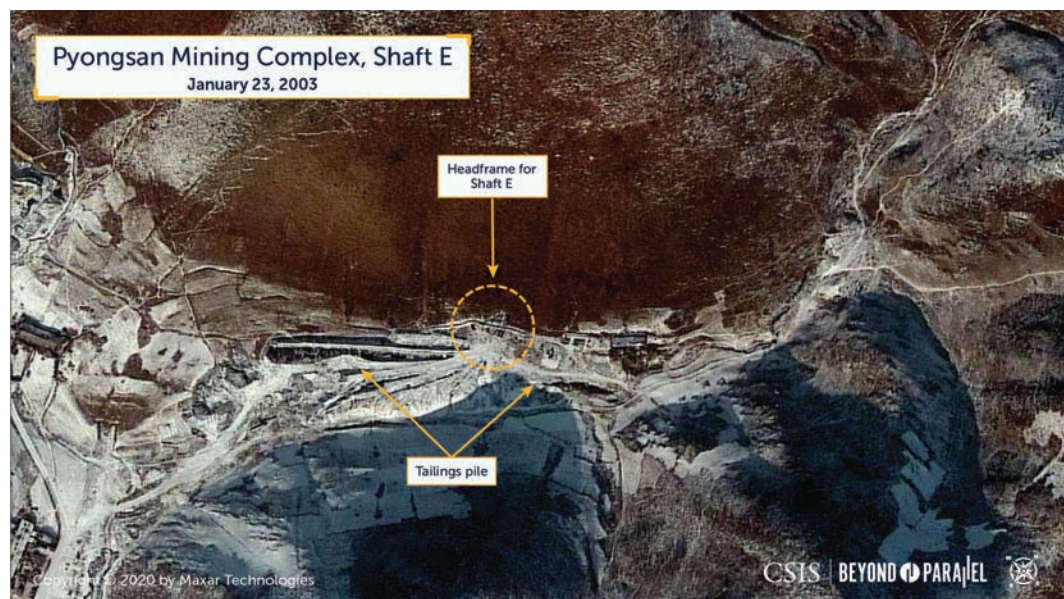
Slide 35: The headframe and tailings piles at Shaft E - January 23, 2003 (Copyright © 2020 by MAXAR Technologies)

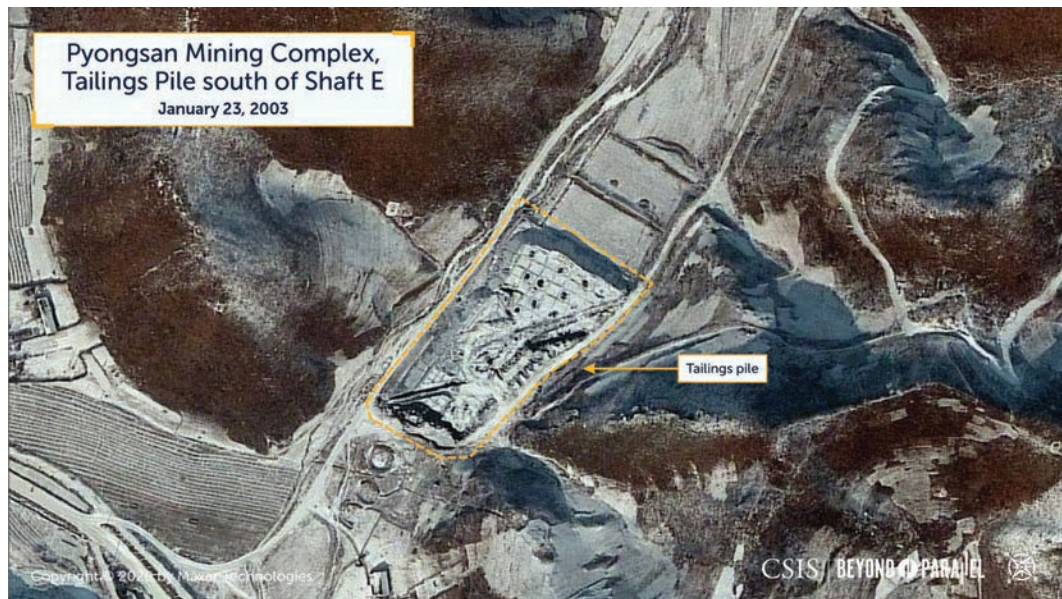
Slide 36: The tailings pile south of Shaft E - January 23, 2003 (Copyright © 2020 by MAXAR Technologies)

- Sometime after the establishment of Shaft E, a large tailings/storage pile was established approximately 625 meters to the south. Satellite imagery from 2003 until 2010 shows that this tailings pile remained relatively untouched. In 2011, however, small sections of it were excavated. The pile then remained unchanged until late 2019 when major portions were excavated. The reasons for this excavation are unknown; however, activity observed here may be related to efforts to recover small quantities of uranium or other minerals.<sup>18</sup>

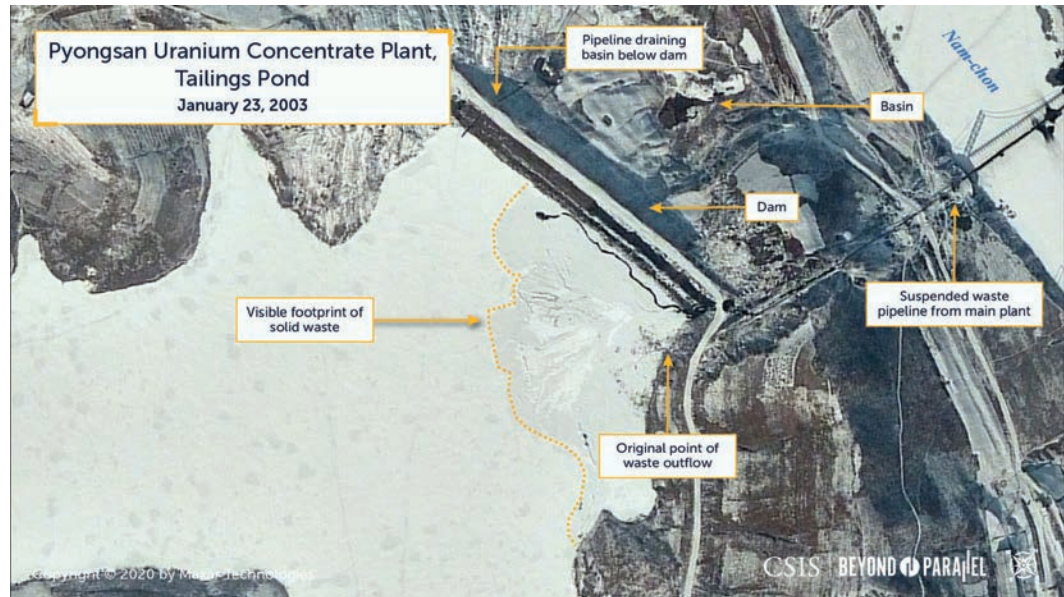
Slide 38: A closeup of the tailings pond and dam showing the original waste outflow point, a small pipeline draining the basin below the dam, and the footprint of the solid waste building in the tailings pond - January 23, 2003 (Copyright © 2020 by MAXAR Technologies)

At this time, the tailings pond covered approximately 23.8 hectares and the precipitated solid waste had a visible footprint of approximately 1.1 hectares. The slurry of liquid and solid waste pumped to the tailings pond arrived at a point just south of the northeast corner of the dam and was initially allowed to naturally spill into the pond and fan out. Subsequently, small ditches were sometimes excavated on top of previously deposited solid waste to further distribute the waste slurry more evenly—first west along the dam and then to the south and southwest. Visible in the image of January 23, 2003, is a small pipeline on the west side of the dam that appears to be draining the basin below the dam.

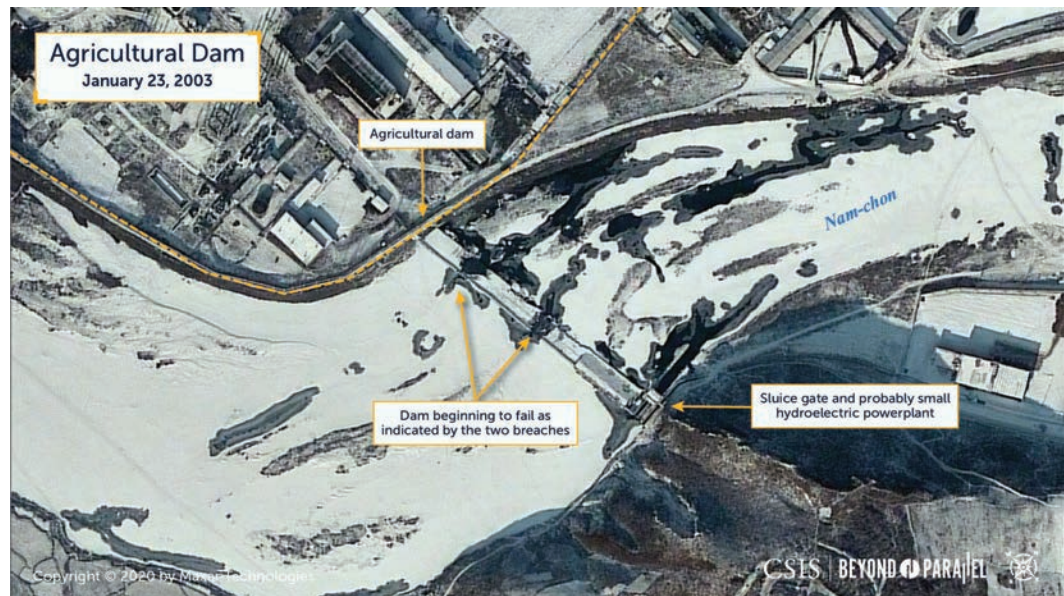
Slide 39: The agricultural dam immediately east of the Pyongsan Uranium Concentrate Plant. What appear to be two small breaches can be seen on the top of the dam - January 23, 2003 (Copyright © 2020 by MAXAR Technologies)

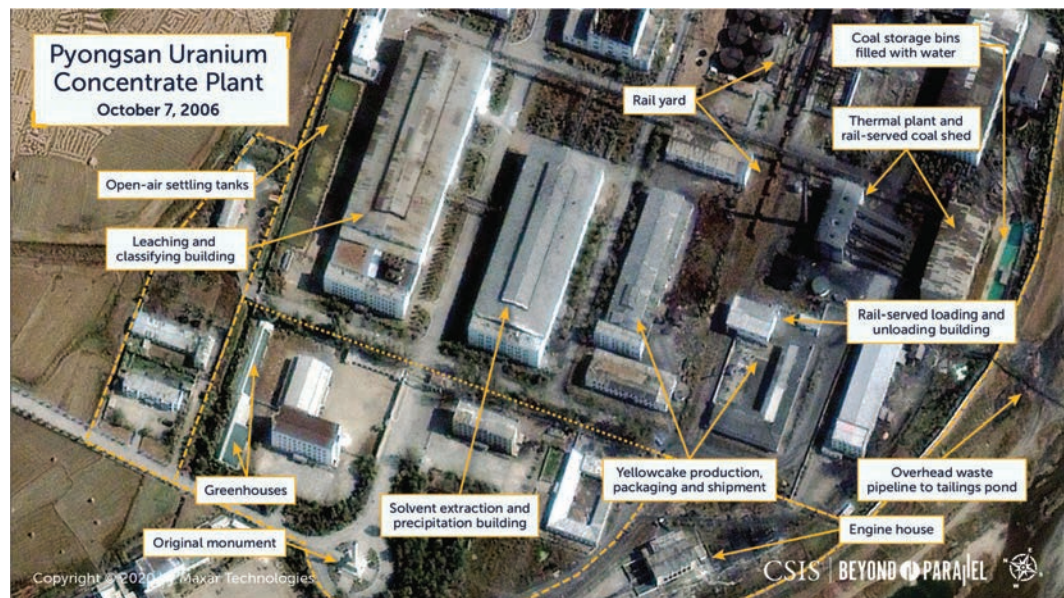
Slide 40: Overview of the western section of the main plant showing the headquarters and administration, processing, and thermal plant areas. Notable are the new open-air settling tanks adjacent to the leaching and classifying building - October 7, 2006 (Copyright © 2020 by MAXAR Technologies)

Activity observed in imagery from April 29, 2005, and October 7, 2006, shows that a greenhouse was added on the north side of the headquarters and administration area and a building on the south side was expanded.<sup>66</sup> More significantly, on the north side of the leaching and classifying building, an approximately 100-meter-by-15-meter above-ground structure consisting of six open-air settling tanks had been built. An overhead conveyor belt system connecting the sampling and grinding building to the central building of the rotary kiln facility was removed, and a roof was added to the central building.

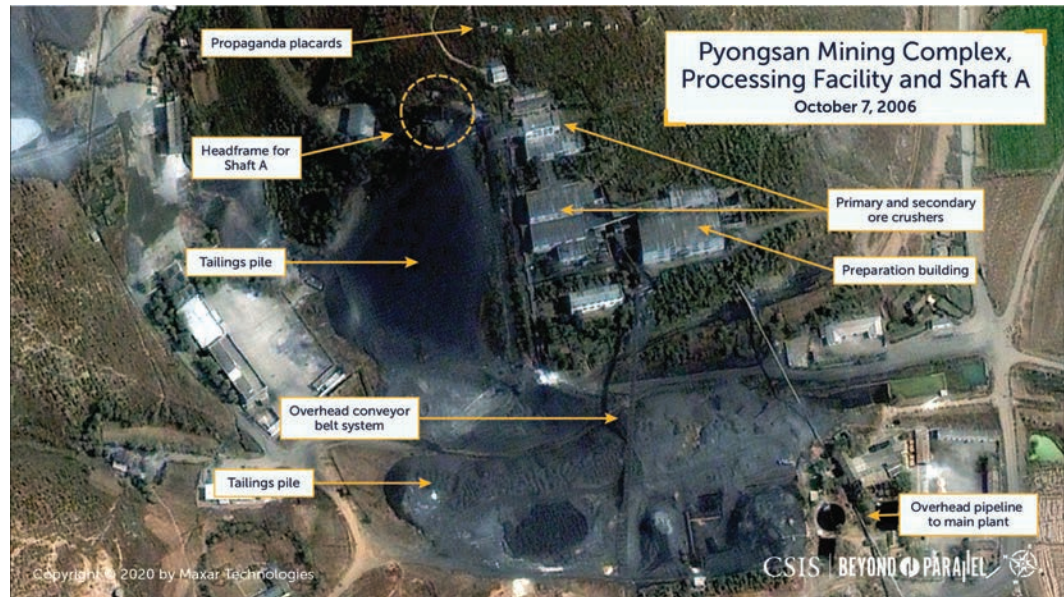
Slide 43: The mine processing facilities, headframe at Shaft A, and associated tailings piles - October 7, 2006  
(Copyright © 2020 by MAXAR Technologies)

The image for October 7, 2006, also provides a clear, detailed view of the mine shafts, their headframes, and tailings piles.

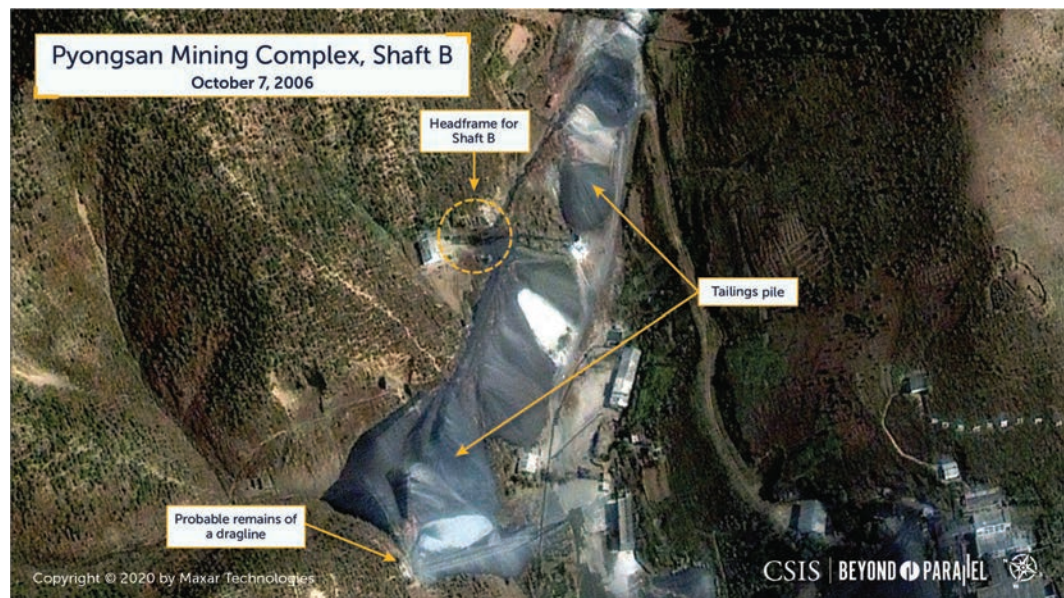
Slide 44: The headframe and tailings piles at Shaft B - October 7, 2006 (Copyright © 2020 by MAXAR Technologies)

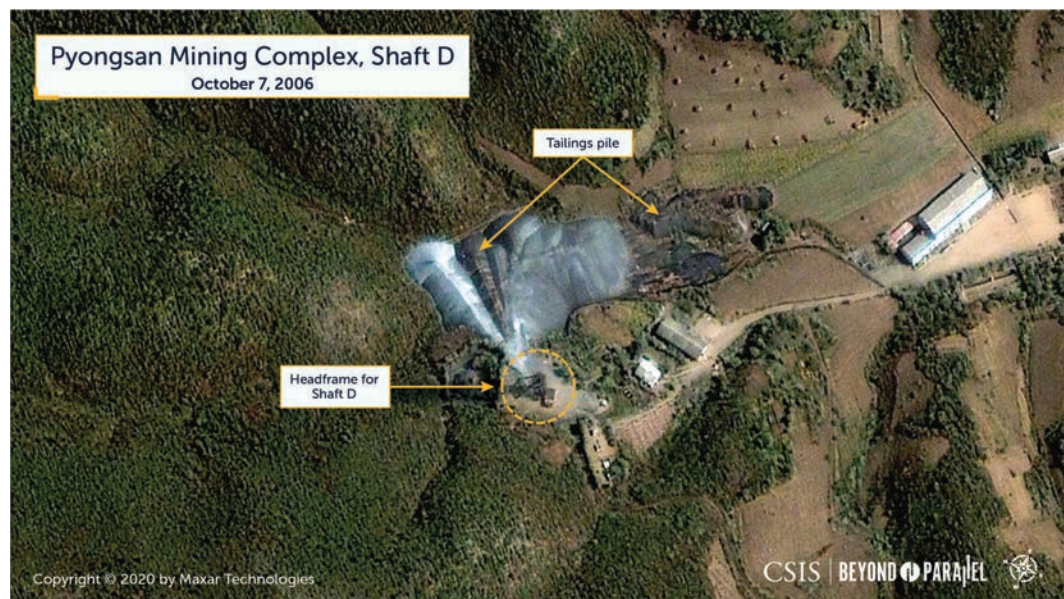
Slide 46: The headframe and tailings piles at Shaft D - October 7, 2006 (Copyright © 2020 by MAXAR Technologies)

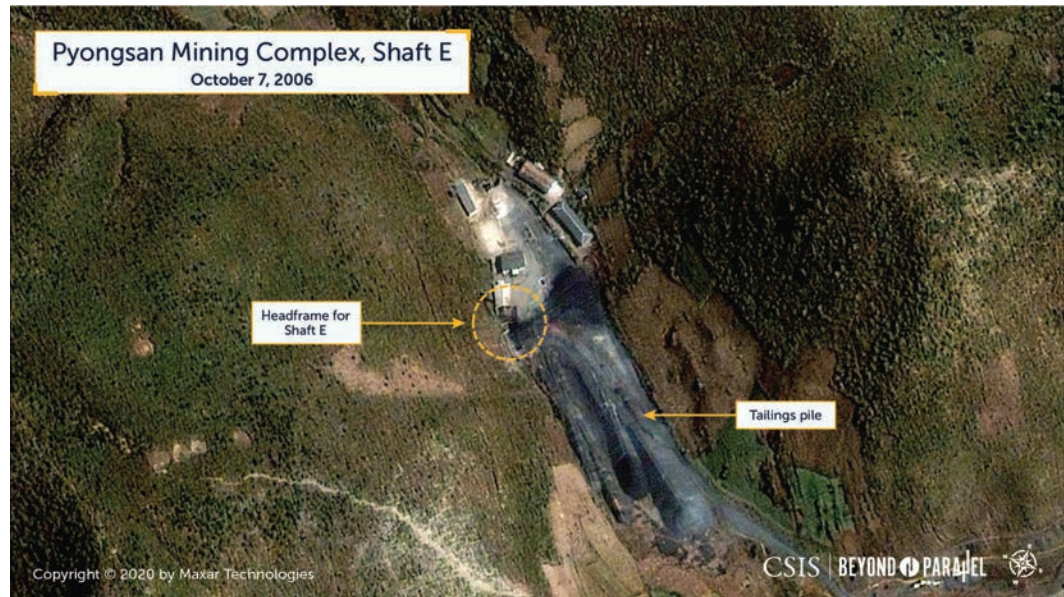
Slide 47: The headframe and tailings piles at Shaft E - October 7, 2006 (Copyright © 2020 by MAXAR Technologies)

- Shaft E began operations during the late-1980s or early-1990s and continued until sometime between August 2010 and March 2011. The headframe was partially removed sometime between 2011 and 2013 and completely removed by July 2017. During July 2018, a new headframe was observed over the shaft. Subsequent imagery shows changes to the tailings pile and indications of road traffic.

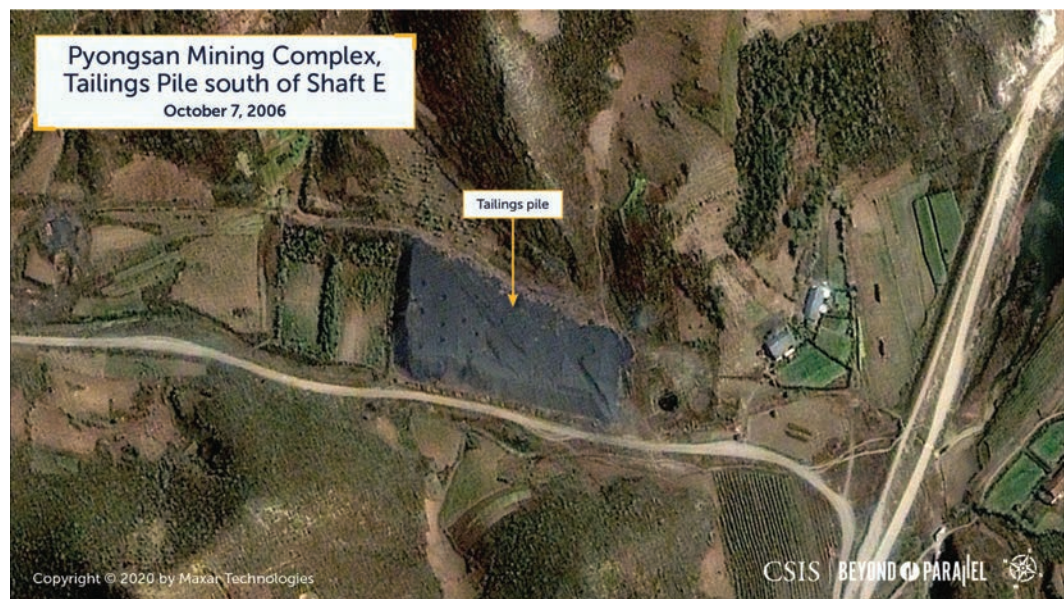
Slide 48 The tailings pile south of Shaft E - October 7, 2006 (Copyright © 2020 by MAXAR Technologies)

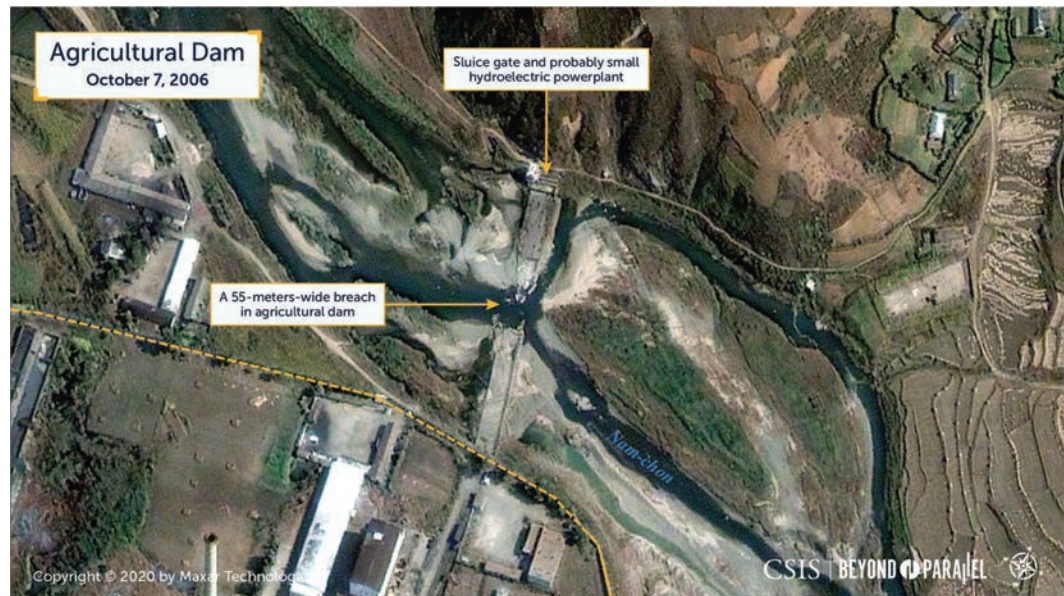
Slide 50: The agricultural dam has failed as seen by the 55-meter-wide breach - October 7, 2006 (Copyright © 2020 by MAXAR Technologies)

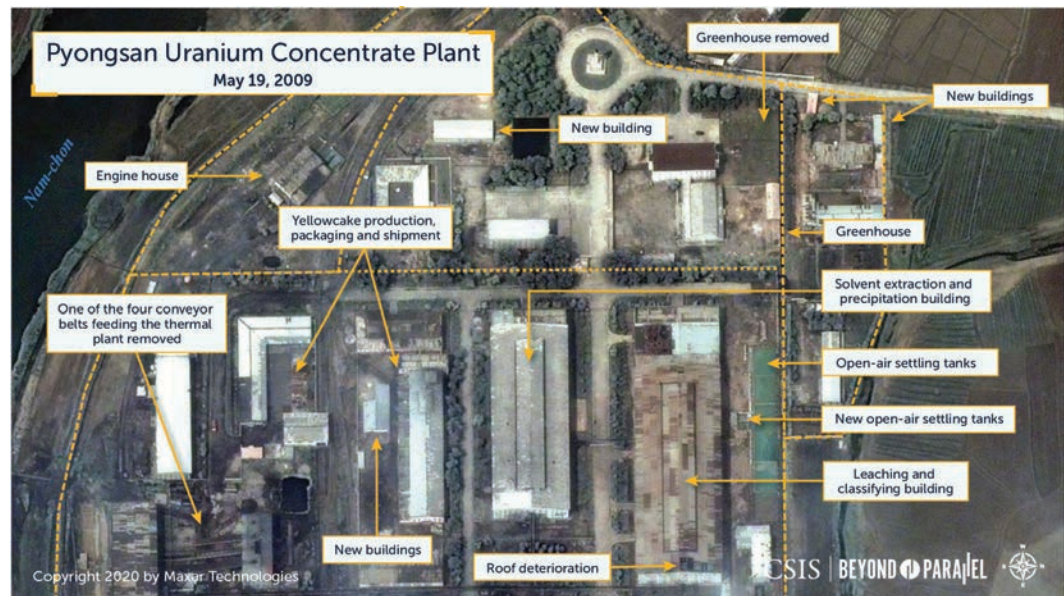
Slide 53: The Overview of the western section of the main plant showing the headquarters and administration, processing, and thermal plant areas - May 19, 2009 (Copyright © 2020 by MAXAR Technologies)

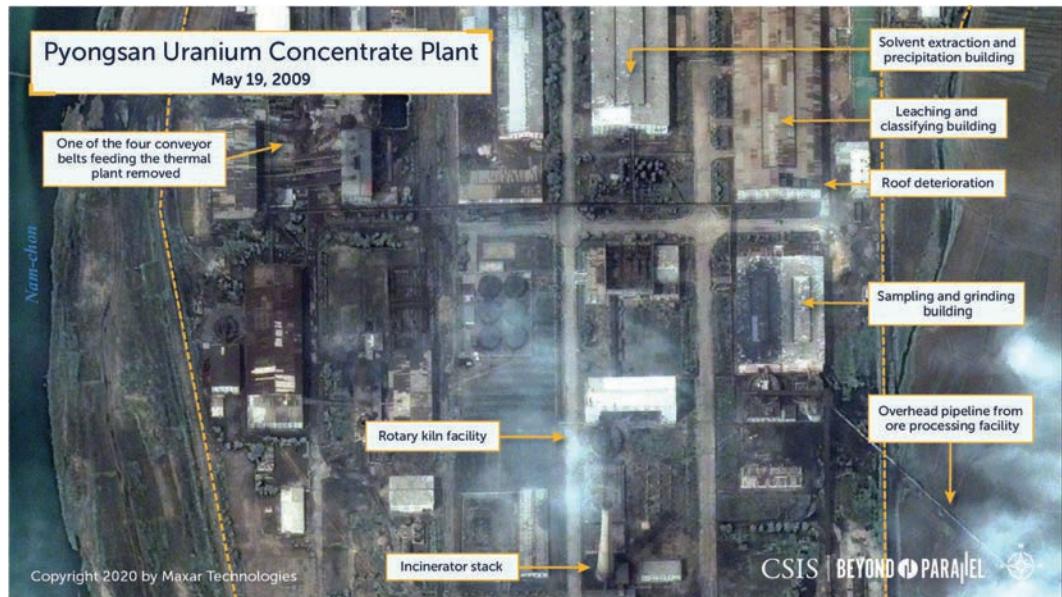
Slide 54: The center section of the main plant showing the thermal plant and processing, waste treatment and areas - May 19, 2009 (Copyright © 2020 by MAXAR Technologies)

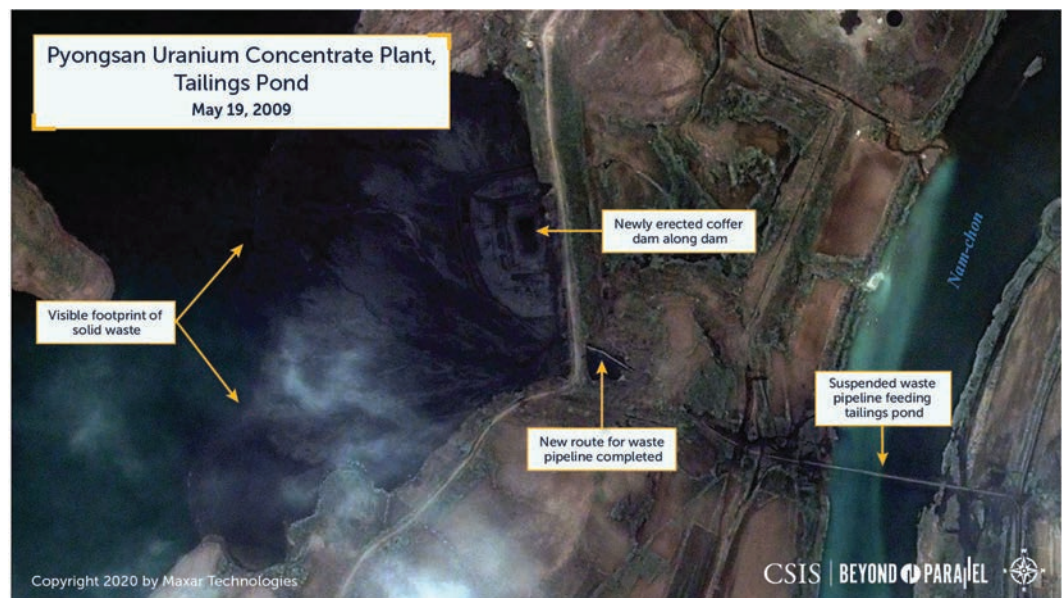
- The presence of a cofferdam at the tailings pond dam from May 2009 through October 2013 suggests that the dam may have experienced some type of structural issue that could have resulted in waste leakage. While water is often seen pooled in the basin at the base of the dam, this may simply be rainwater settling in a low point rather than seepage from the dam.

Slide 55: The tailings pond showing the rerouting of the waste pipeline had been completed and the recent construction of a cofferdam along the inside face of the dam - May 19, 2009 (Copyright © 2020 by MAXAR Technologies)

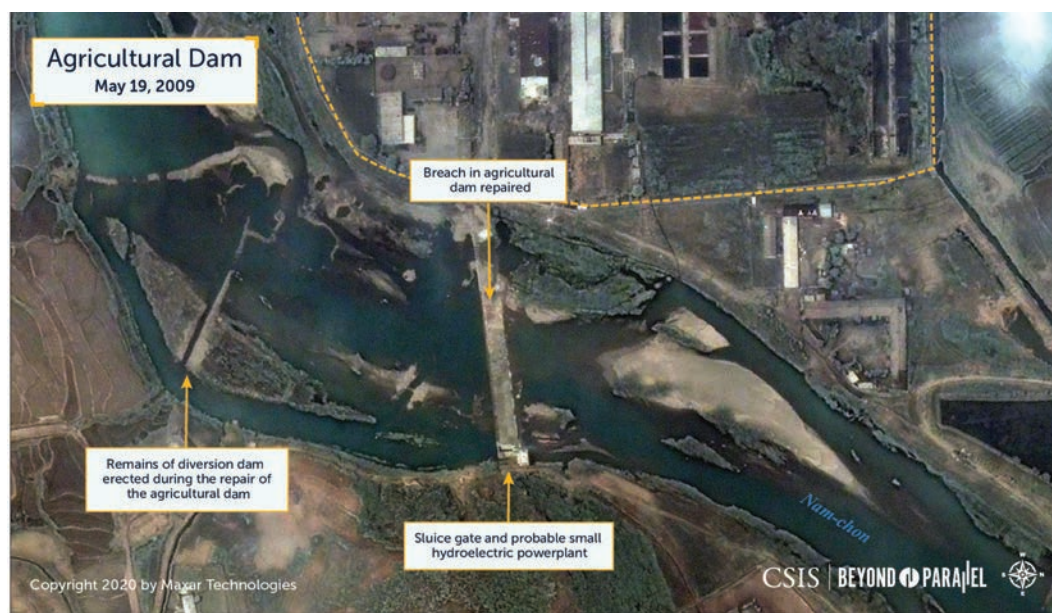
Slide 56: The breach in the agricultural dam had been repaired - May 19, 2009 (Copyright © 2020 by MAXAR Technologies)

The image for May 19, 2009, shows that the breach in the agricultural dam had been repaired.

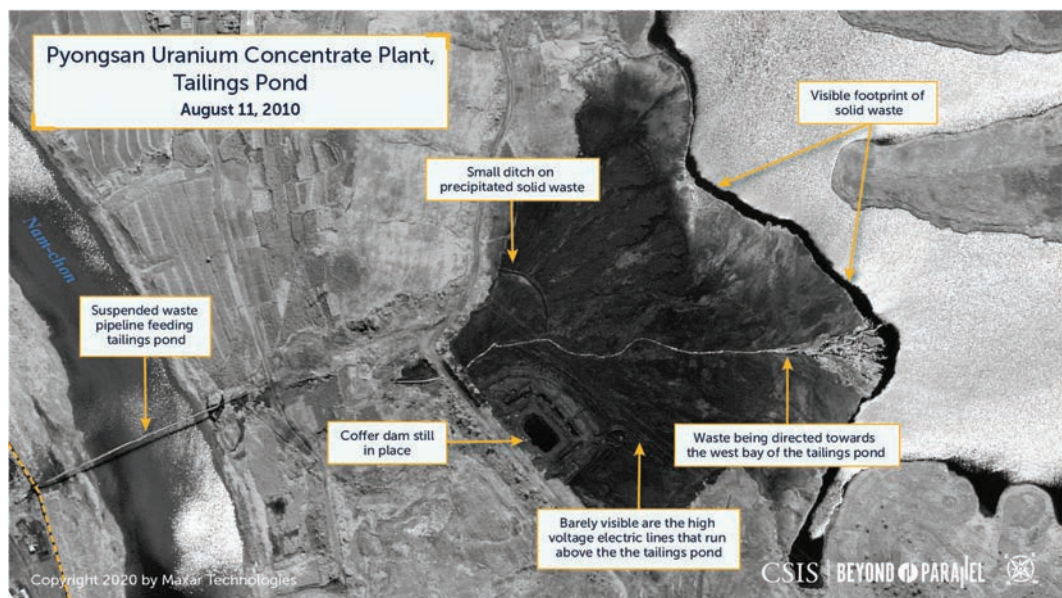
Slide 60: The tailings pond dam showing the cofferdam still in place along the inside of the dam, expanding precipitated solid waste, and ditches being excavated on the precipitated waste to reroute the waste outflow stream - August 11, 2010 (Copyright © 2020 by MAXAR Technologies)

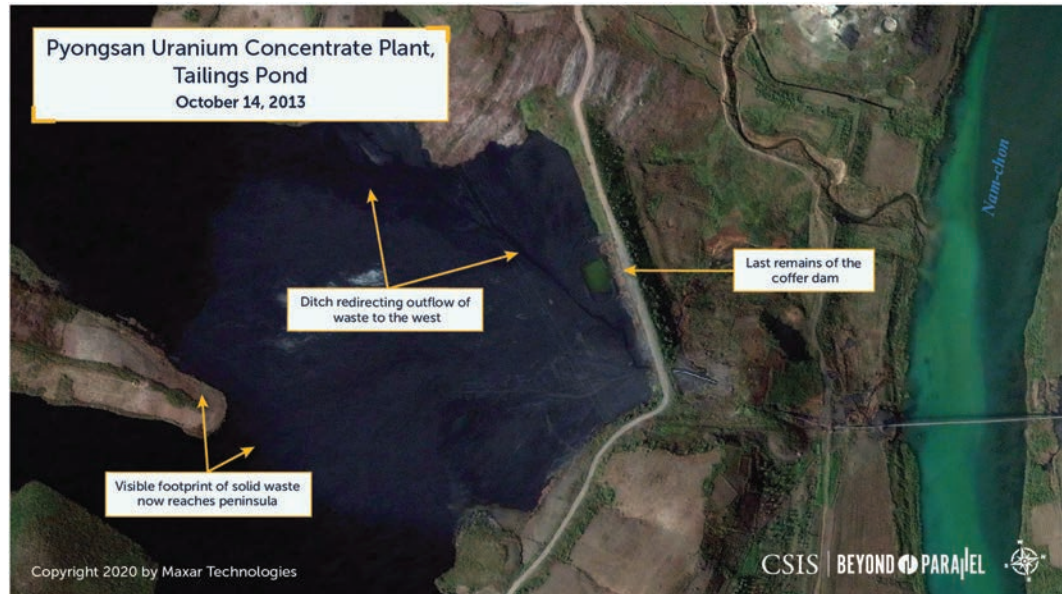
Slide 66: The tailings pond dam showing the final remains of the cofferdam just visible and the footprint precipitated solid waste now extends to the small peninsula separating the east and west bays - October 14, 2013 (Copyright © 2020 by MAXAR Technologies)

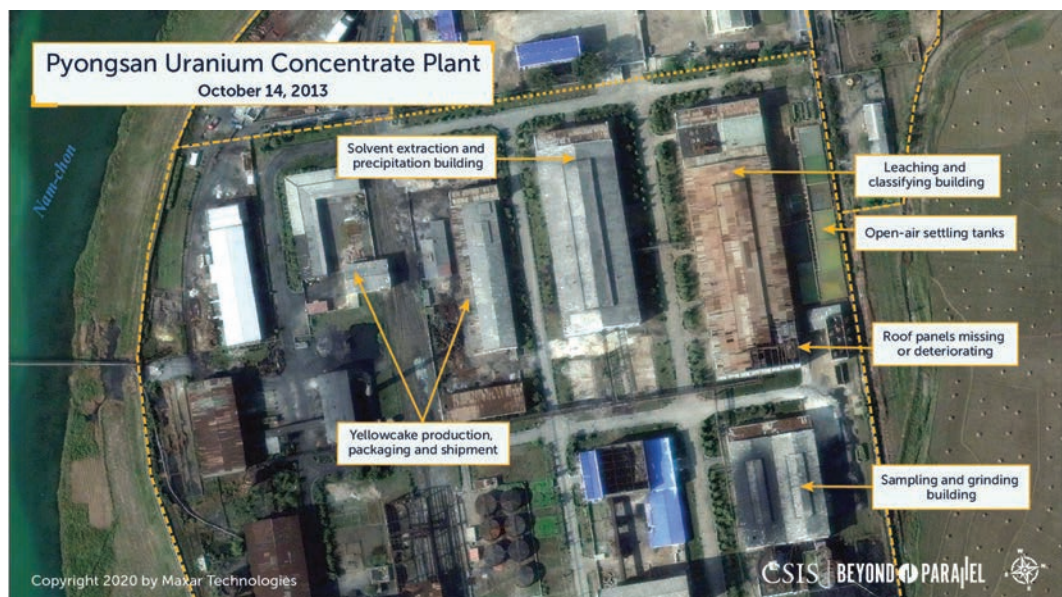
Slide 67: The western and central sections of the main plant showing the significant increase in the degradation of the leaching and classifying building's roof - October 14, 2013 (Copyright © 2020 by MAXAR Technologies)

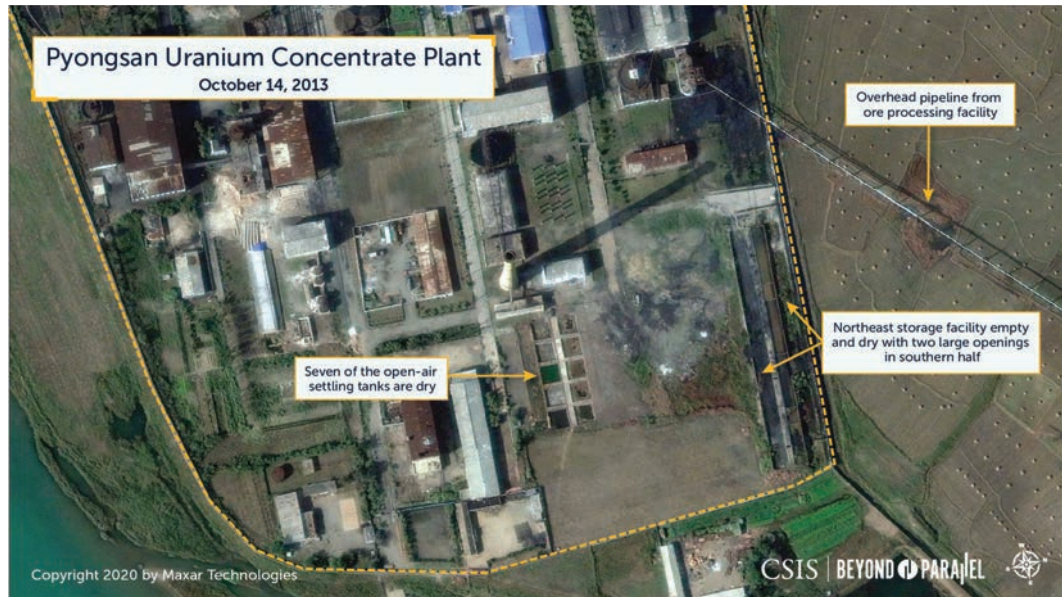
Slide 68: The eastern section of the main plant showing the changes to the northeast waste storage facility and the open-air settling tanks east of the rotary kiln facility - October 14, 2013 (Copyright © 2020 by MAXAR Technologies)
