# Pyongsan Uranium Concentrate Plant (Nam-chon Chemical Complex)

*Infrastructure Development and Status*

A Report of the CSIS KOREA CHAIR

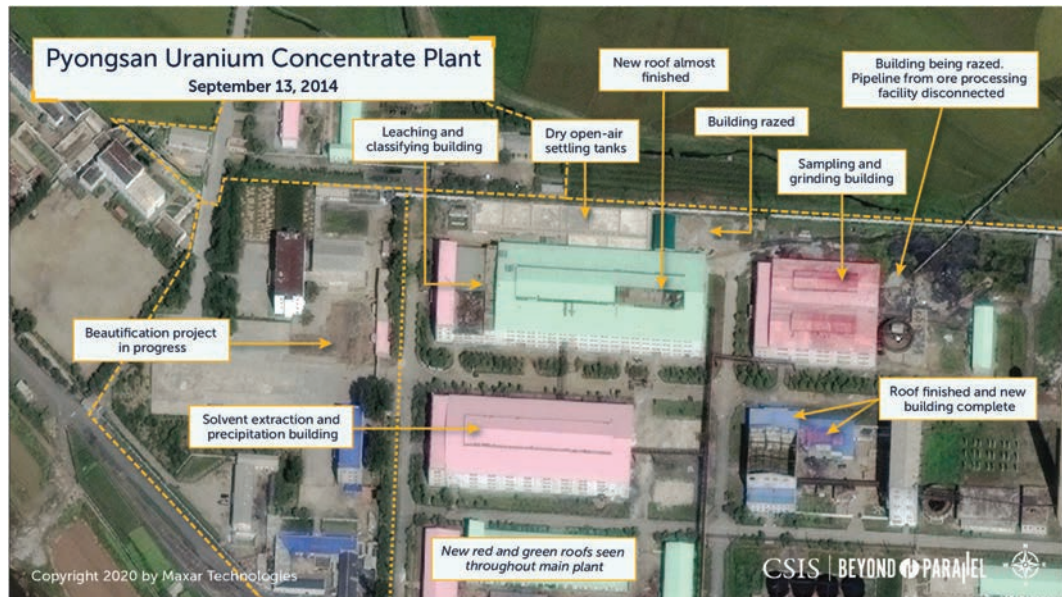
Slide 69: The headquarters and administration area and northwest section of the main plant showing the progress of the ongoing roof replacement project, the dry open-air settling tanks on the north side of the leaching and classifying building, and the razing of the building adjacent to the sampling and grinding building - September 13, 2014 (Copyright © 2020 by MAXAR Technologies)

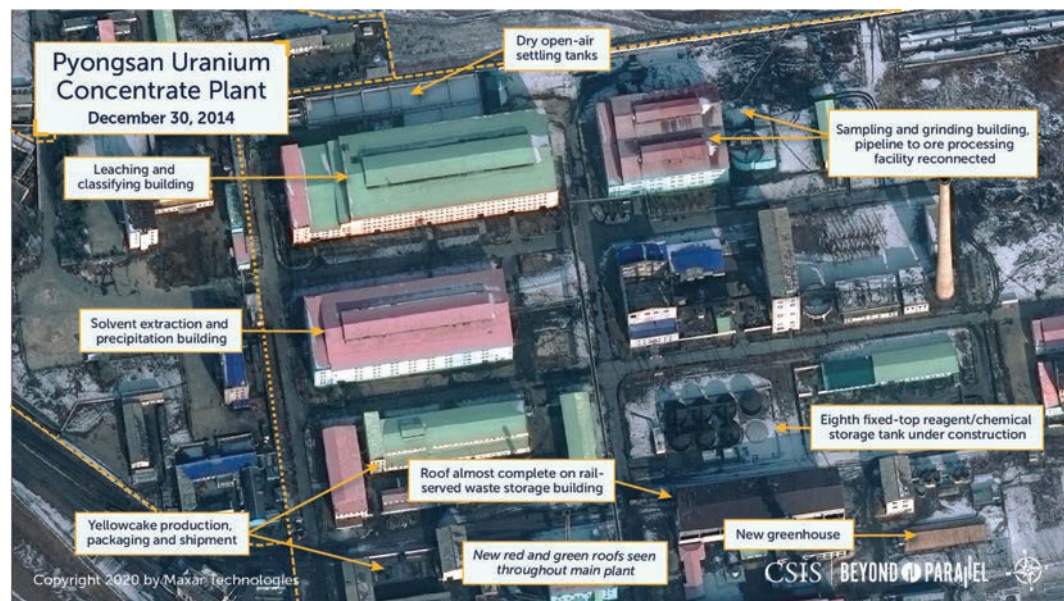
Slide 72: The headquarters and administration area and northwest and central sections of the main plant showing the dry open-air settling tanks on the north side of the leaching and classifying building, foundation for an eighth fixed-top storage, and the new greenhouse - December 30, 2014 (Copyright © 2020 by MAXAR Technologies)

The construction, operation, and subsequent razing of the open-air settling tank east of the rotary kiln facility during 2009 to 2014, while the original open-air settling tanks at the leaching and classifying building continued to operate, suggests three likely explanations:

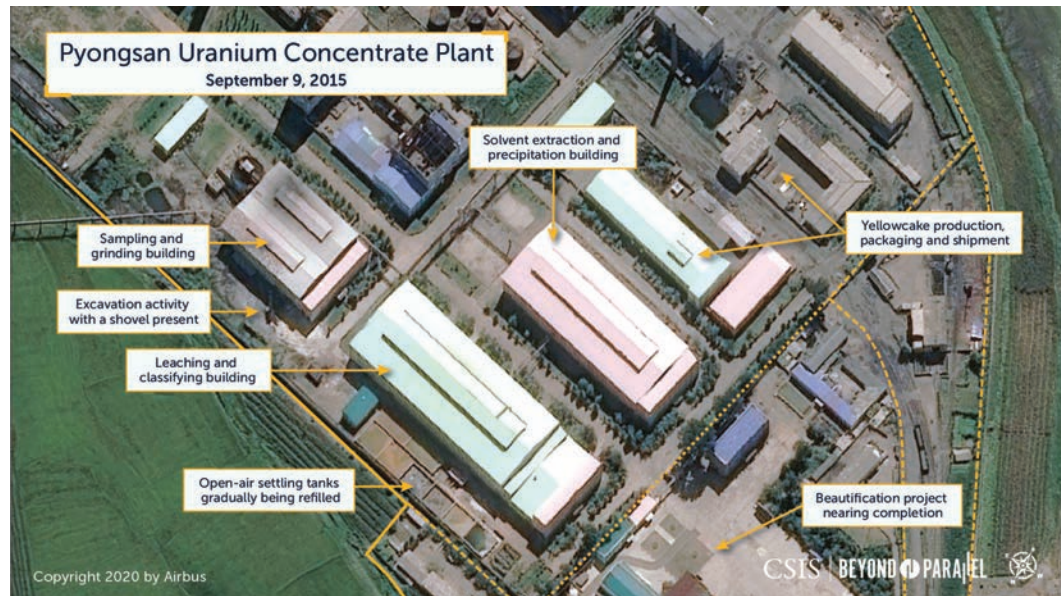
Slide 74: The central section of the main plant showing the roof replacements on the buildings in these areas. The pipeline from the ore processing facility to the sampling and grinding building was now connected, and the open-air storage tanks at the leaching and classifying building were being used again - September 9, 2015 (Copyright © 2020 by Airbus)

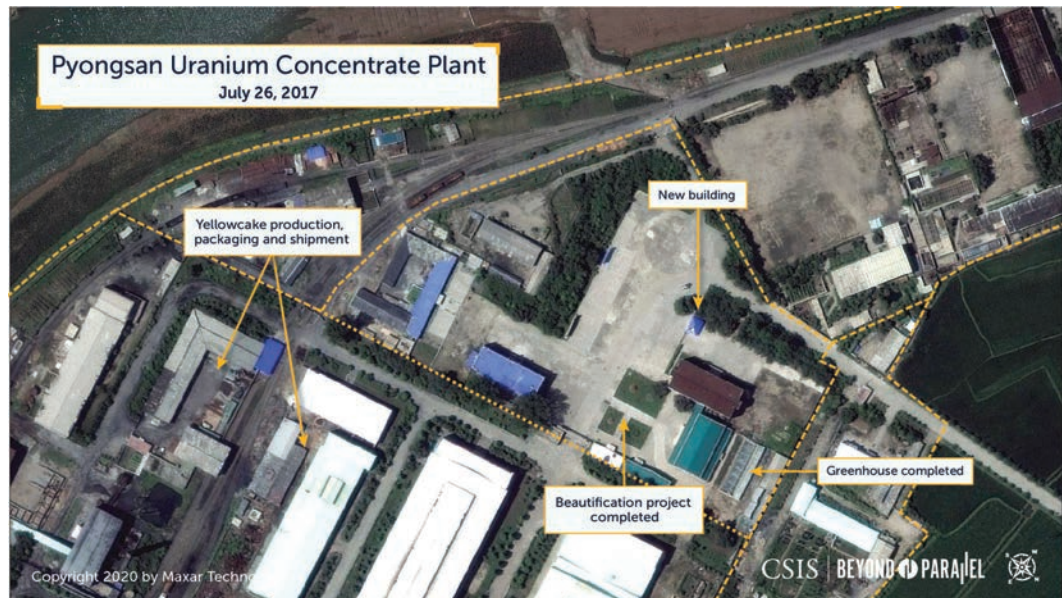
Slide 78: The headquarters and administration area and northwest section showing the construction of a small building (likely a guard booth) and a new greenhouse – July 26, 2017 (Copyright © 2020 by MAXAR Technologies)

With the larger maintenance and modernization projects completed, an image from July 26, 2017, now shows that a number of smaller but important projects were being undertaken. These included the construction of a small building (likely a guard booth) and greenhouse within the headquarters and administration area, the pouring of a new building foundation between the coal storage shed and the thermal plant, the removal of an overhead pipe leading from the center building to the incinerator and stack, the

construction of two small buildings within the rotary kiln facility, and the continued construction progress on the two double-wall silos/stacks between the rail-served waste storage building and wastewater treatment building. On the east side of the plant, two greenhouses were completed, two new support buildings were built or under construction, and the northeast waste storage facility that had the openings closed-in was again being used to store waste from the sampling and grinding building.

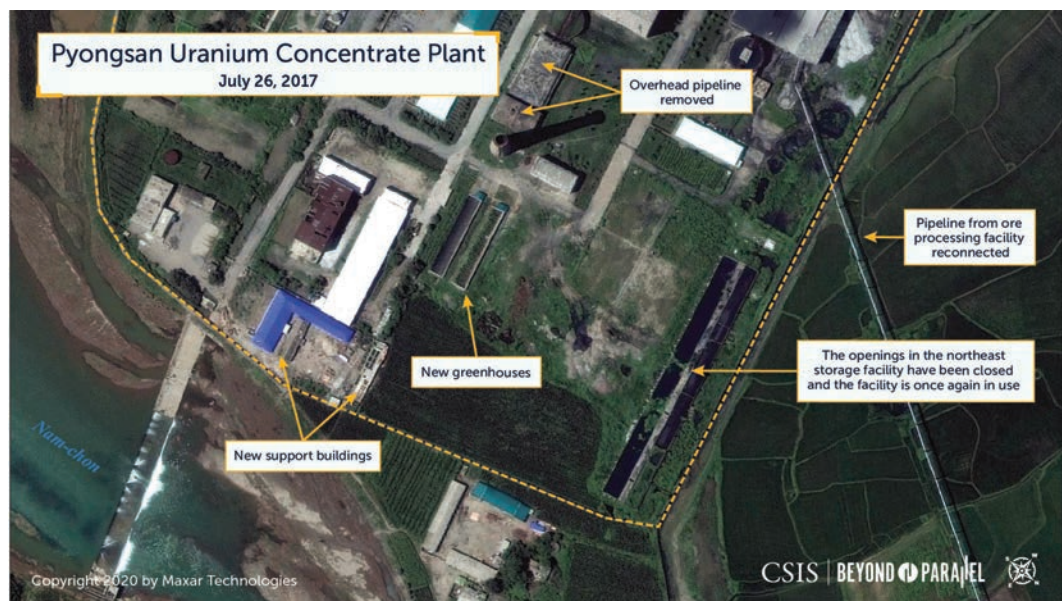
Slide 81: The eastern section of the plant showing the removal of an overhead pipeline within the rotary kiln facility - July 26, 2017 (Copyright © 2020 by MAXAR Technologies)

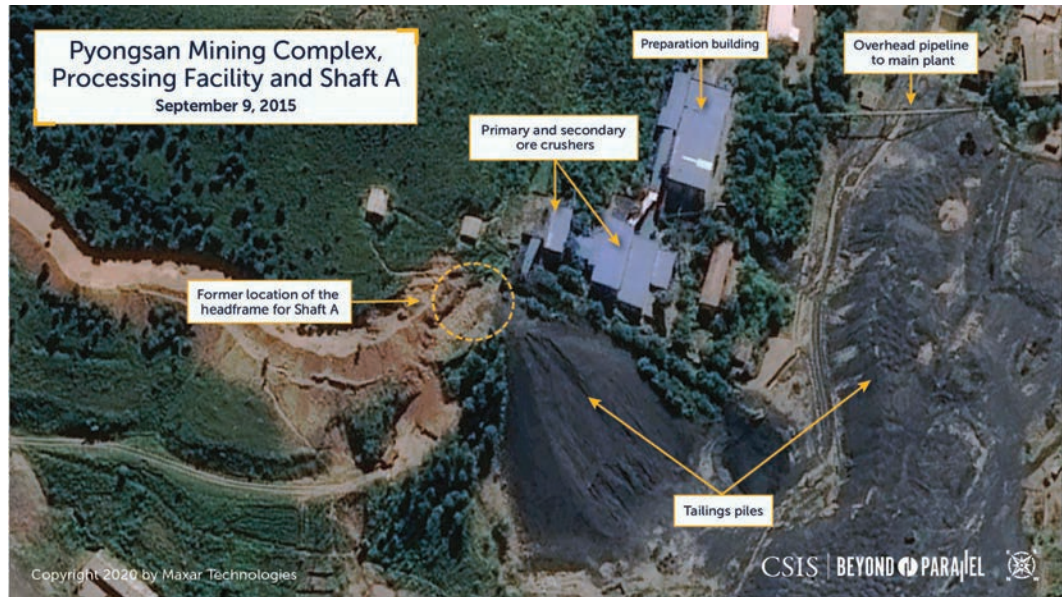
Slide 82: The ore processing facilities and the former location of the Shaft A headframe, which has been removed - September 9, 2015 (Copyright © 2020 by MAXAR Technologies)

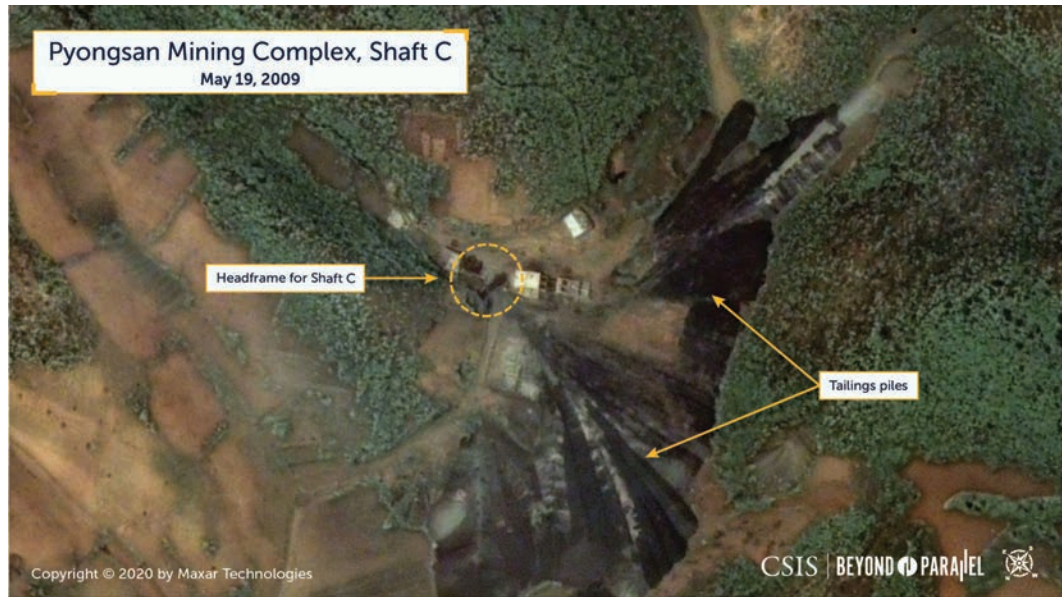
Slide 84: The headframe and tailings piles at Shaft C - May 19, 2009 (Copyright © 2020 by MAXAR Technologies)

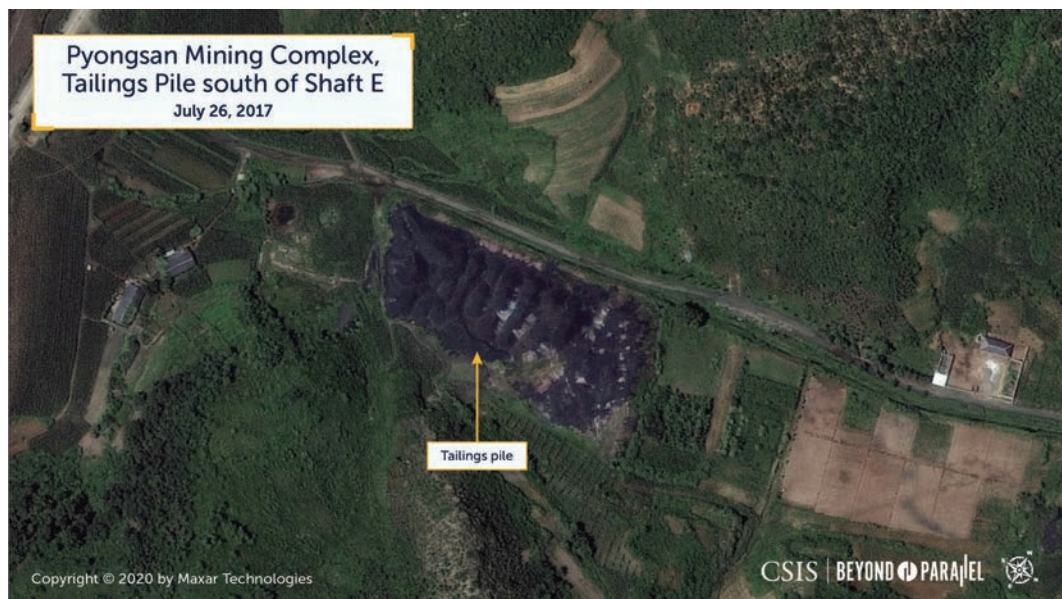
Slide 87: The tailings pile south of Shaft E - July 26, 2017 (Copyright © 2020 by MAXAR Technologies)

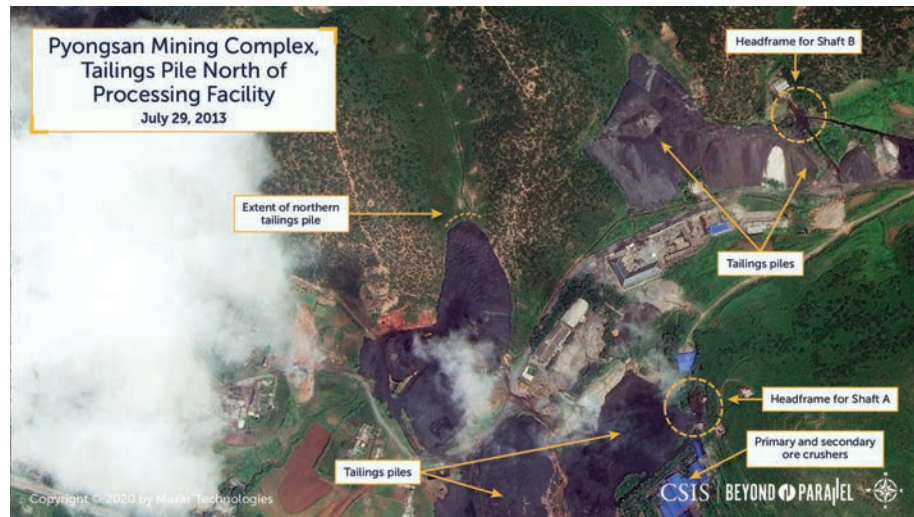
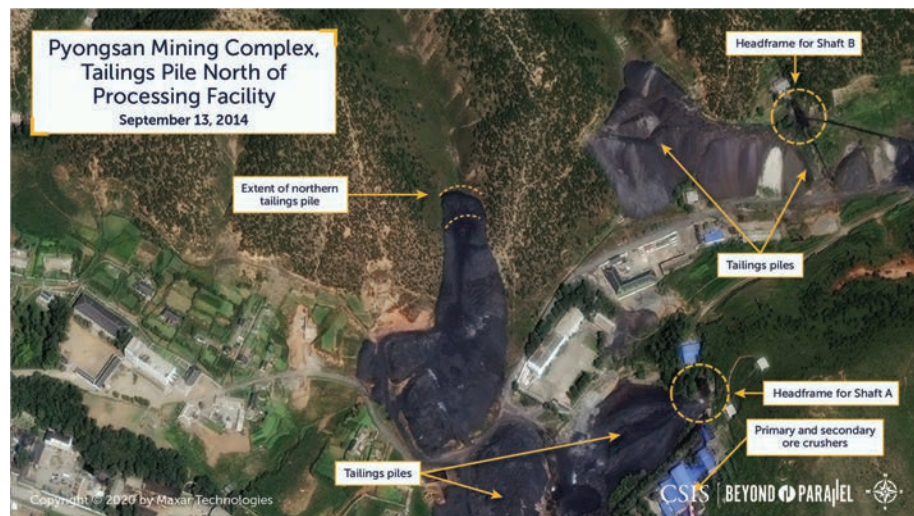
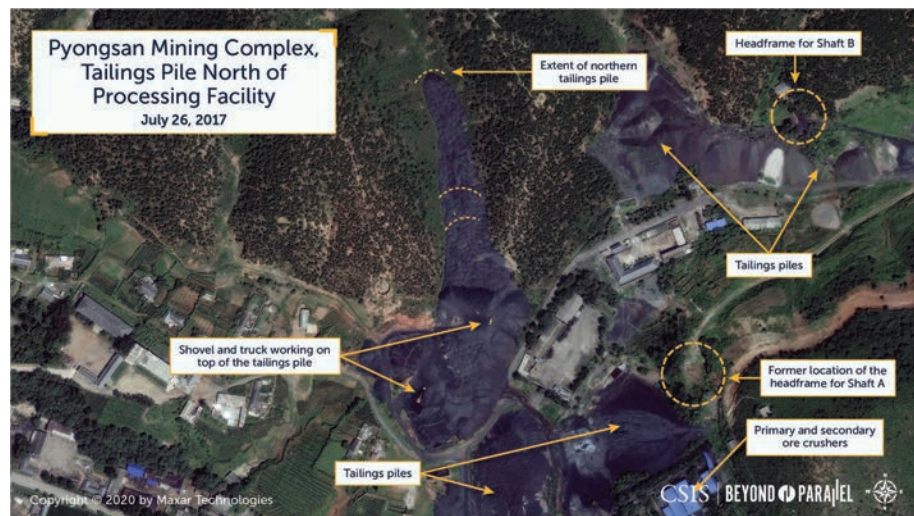
Slides 88–90: A series of images showing the growth of the tailings pile north of the ore processing facility - 2013-2017 (Copyright © 2020 by MAXAR Technologies)

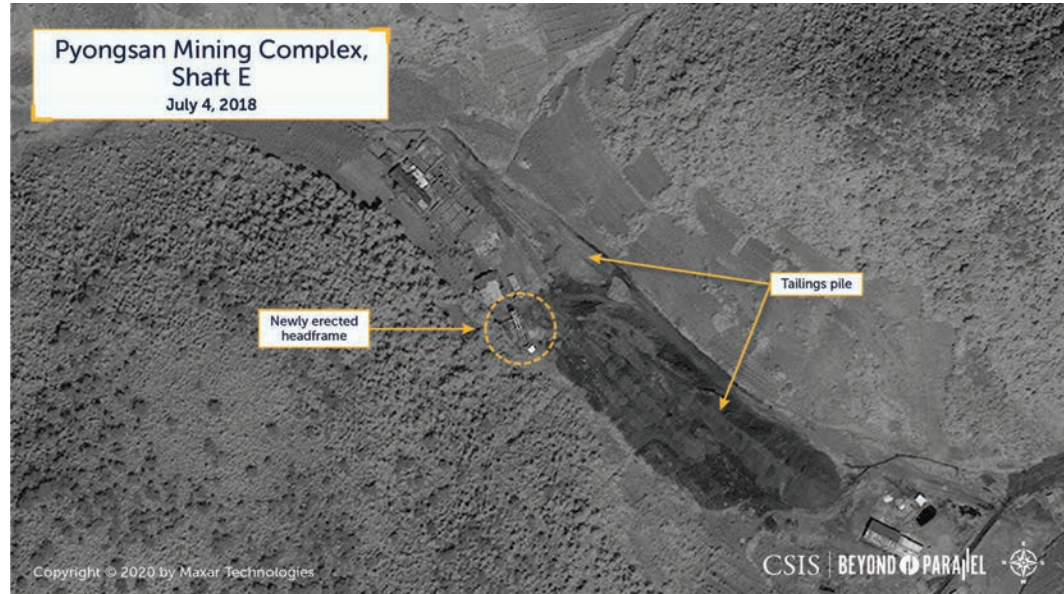
The image for July 4, 2018, also shows a newly erected headframe over Shaft E. The original headframe here was partially removed sometime between 2011 and 2013 and completely removed by July 2017.

Slide 96: The new headframe installed at Shaft E - July 4, 2018 (Copyright © 2020 by MAXAR Technologies)

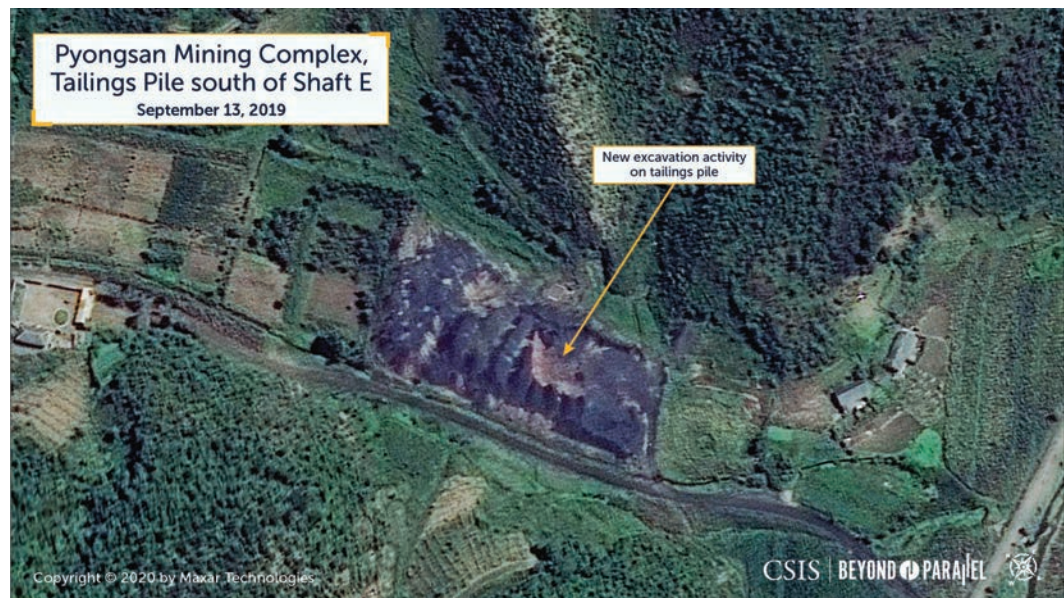
Slide 98: A view of the excavation activity at the tailings pile south of Shaft E - September 13, 2019 (Copyright © 2020 by MAXAR Technologies)
