Briefing
- the Cheonan Situation -

Ambassador Han, Duk-soo

(1) External Explosion : JIG conclusion

- Underwater explosion outside the ship
- Bottom left(port) side of the gas turbine room
- Explosion direction : bottom left → top right

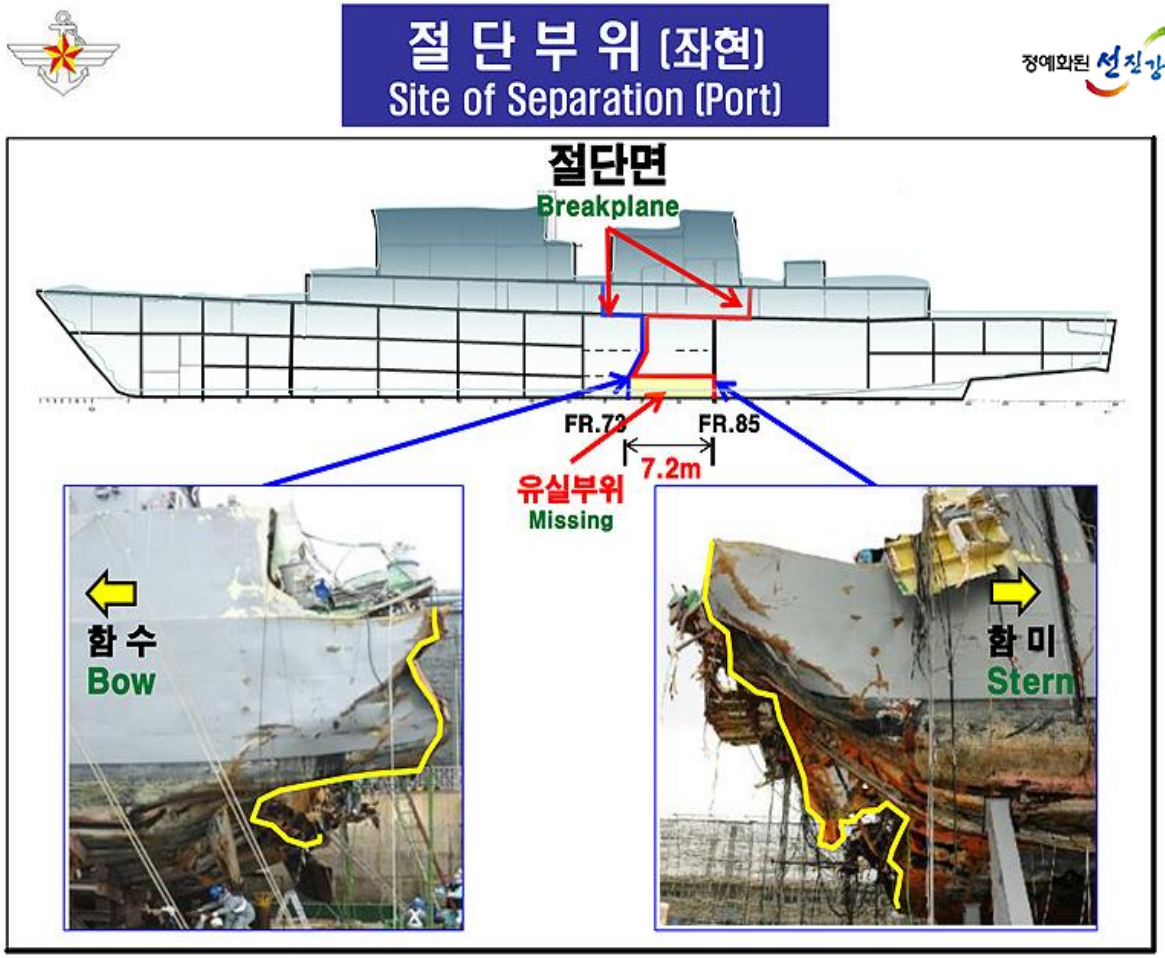
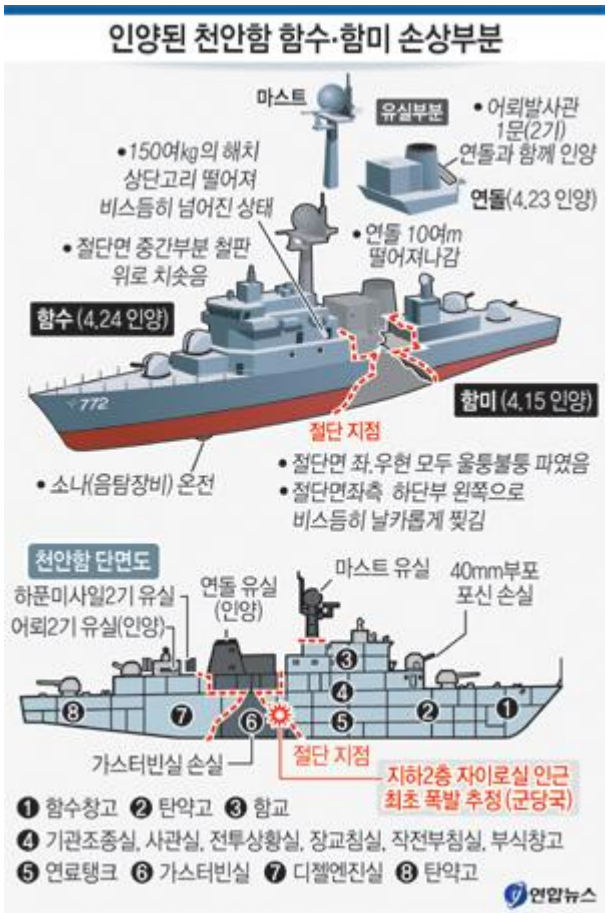
(1) External Explosion Proof : location beneath gas turbine room

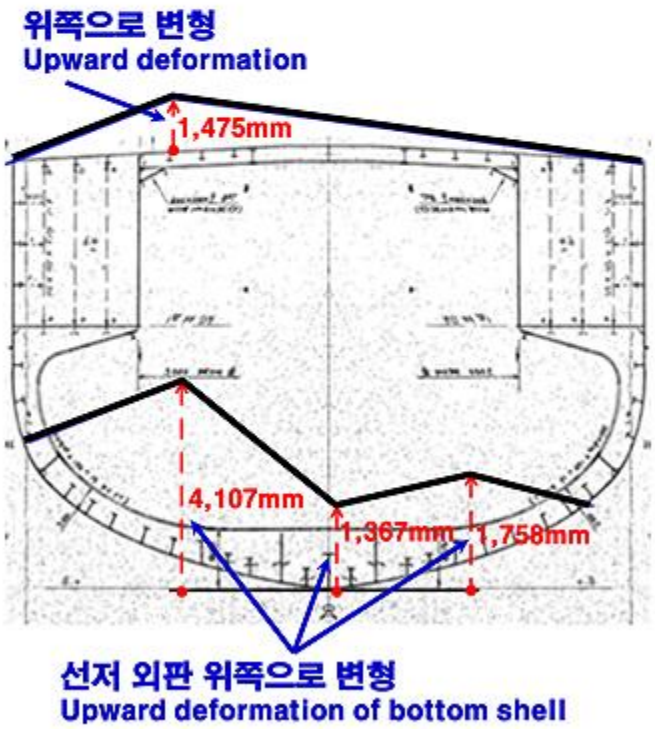
함 수 절 단 면
Bow Breakplane

(1) External Explosion Proof : configuration

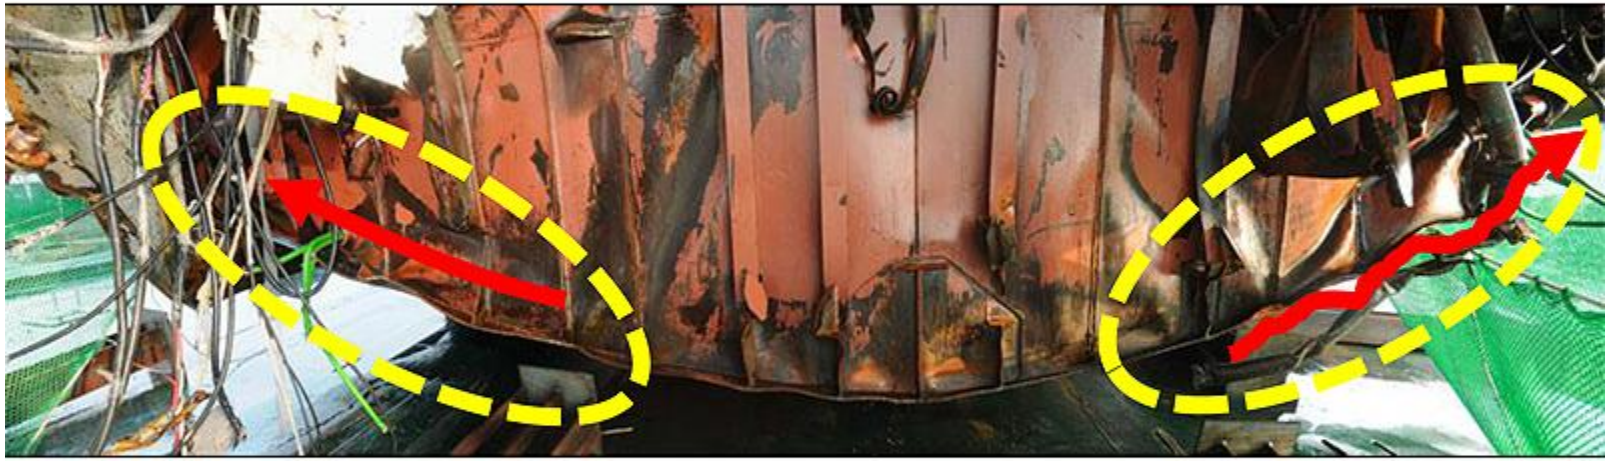
절 단 면
Breakplane

우측으로 말려 올라간 용골
Keel bent upward to the right

뒤틀려 있는 좌현
Twisted portside

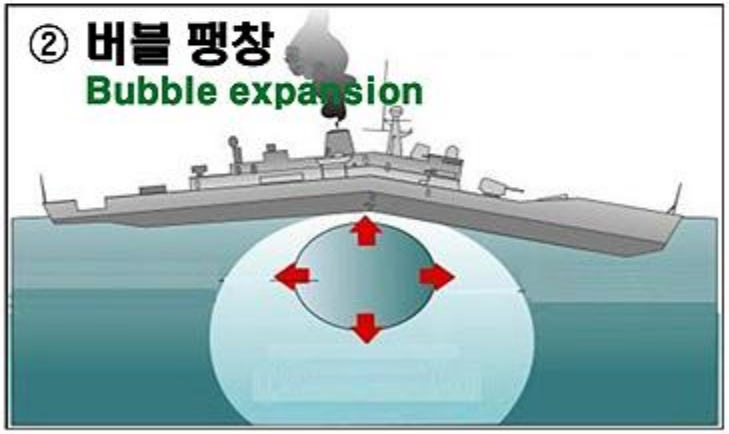
버 블 진 행 과 정 (1/3)
Bubble Process

(2) Torpedo Explosion (What Happens?)

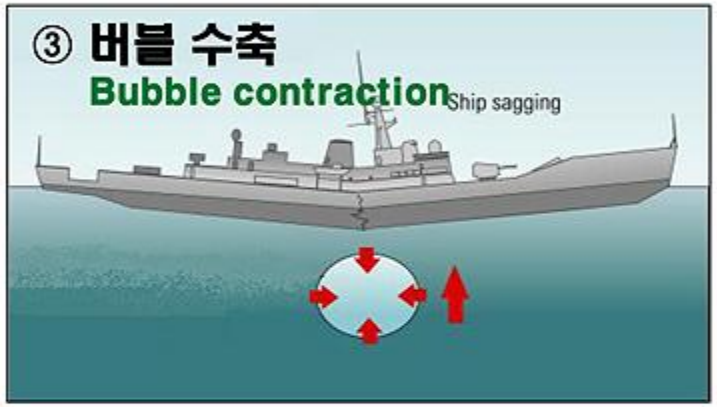
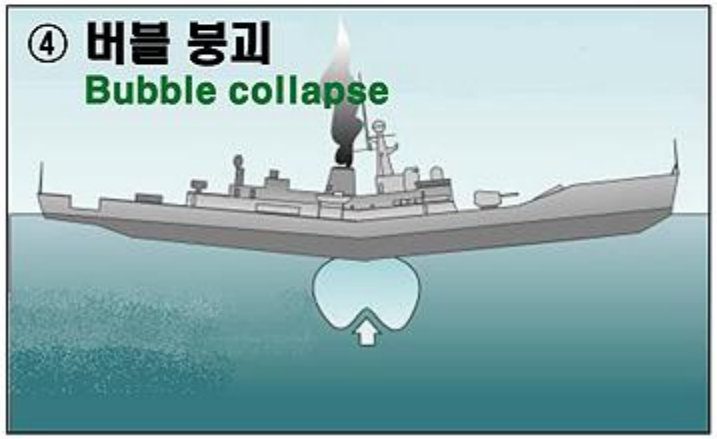
버 블 진 행 과 정 (2/3)
Bubble Process

(2) Torpedo Explosion (What Happens?)

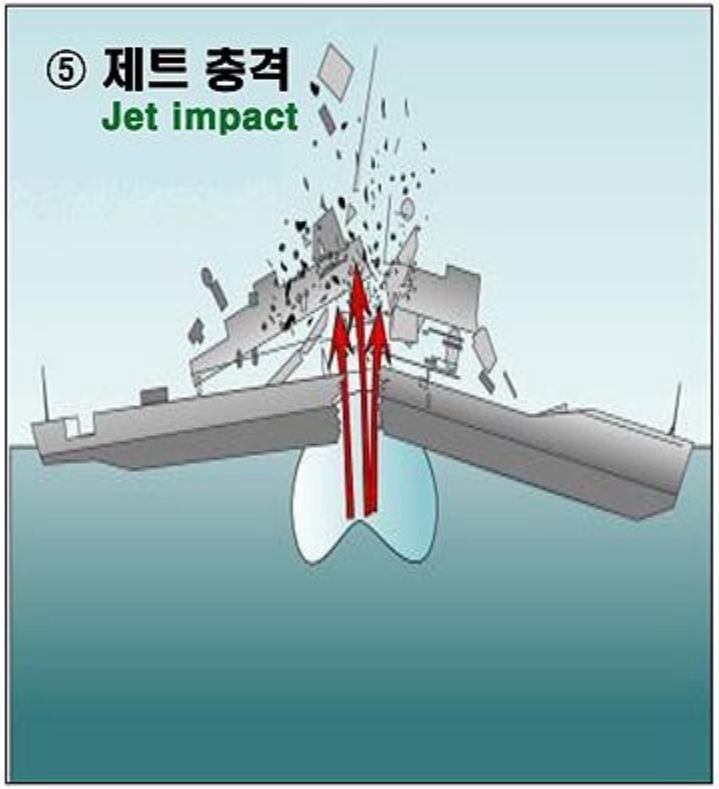
버 블 진 행 과 정 (3/3)
Bubble Process

(2) Torpedo Explosion (What Happens?)

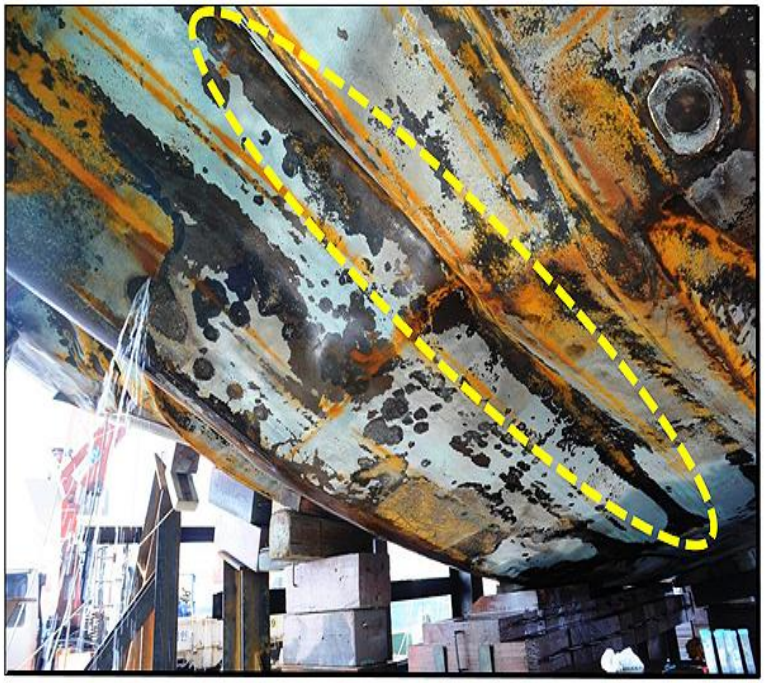
절 단 면
Breakplane

우현 바닥 버블 흔
Trace of bubble on the starboard side bottom

선저부 압력흔
Water pressure marks at the hull bottom

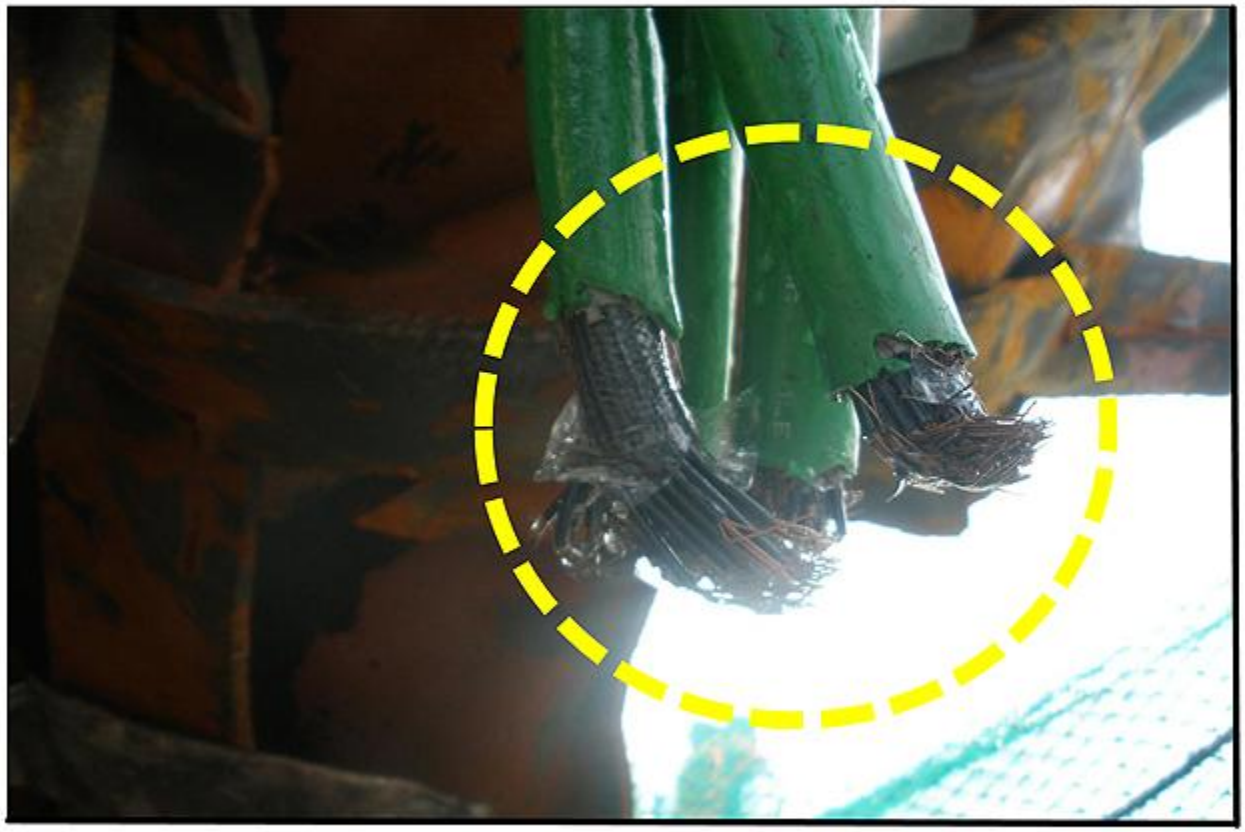
절 단 면
Breakplane

절단된 배선
Truncated wiring

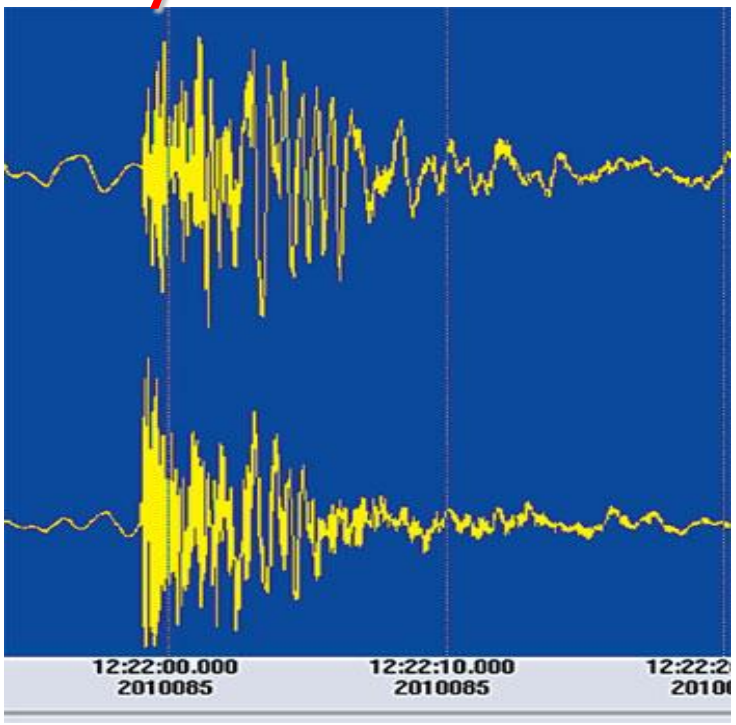
KMA Seismograph near Baengnyong Is.

- Seismic wave:1.5
- 2 infrasound wave: 1.1 second interval
- Testimony
  - 2 explosion sound
  - Pillar of white flash
- Medical exam
  - No fragmentation/burn
  - Fractures, lacerations

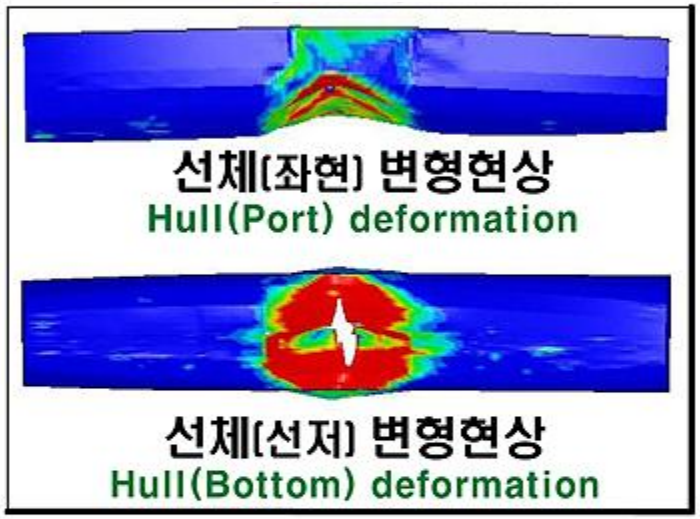
시뮬레이션 결과
Simulation Result

Explosion of about 250kg high explosive at 6~9m in water depth and at 3m to port from center line of gas turbine room results in similar deformation as seen on ROKS Cheonan

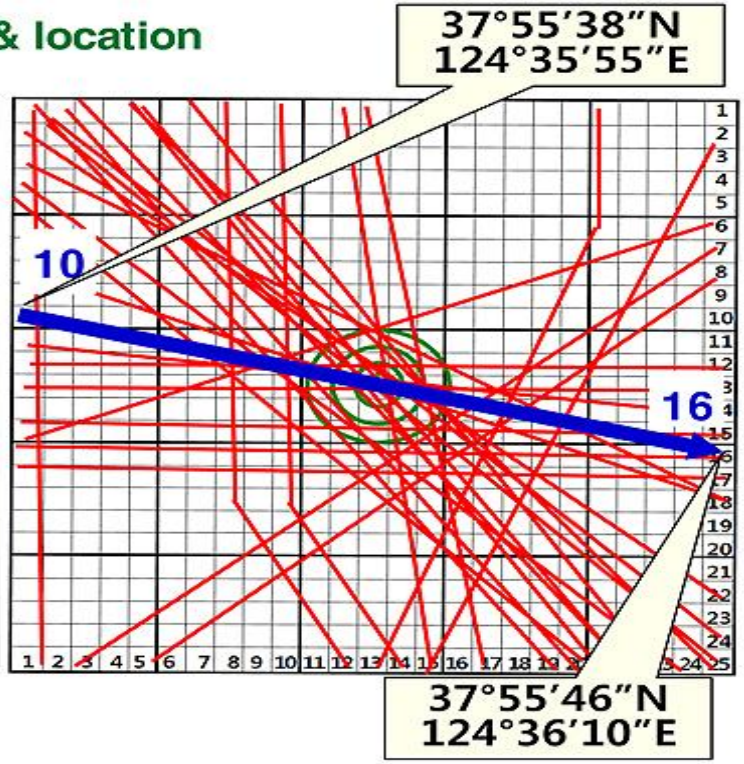
□ 수거 일시 / 위치 Recovery time & location

Time : 0925 hrs, 15 May ’10 (Sat)

Location : Around the point of explosion

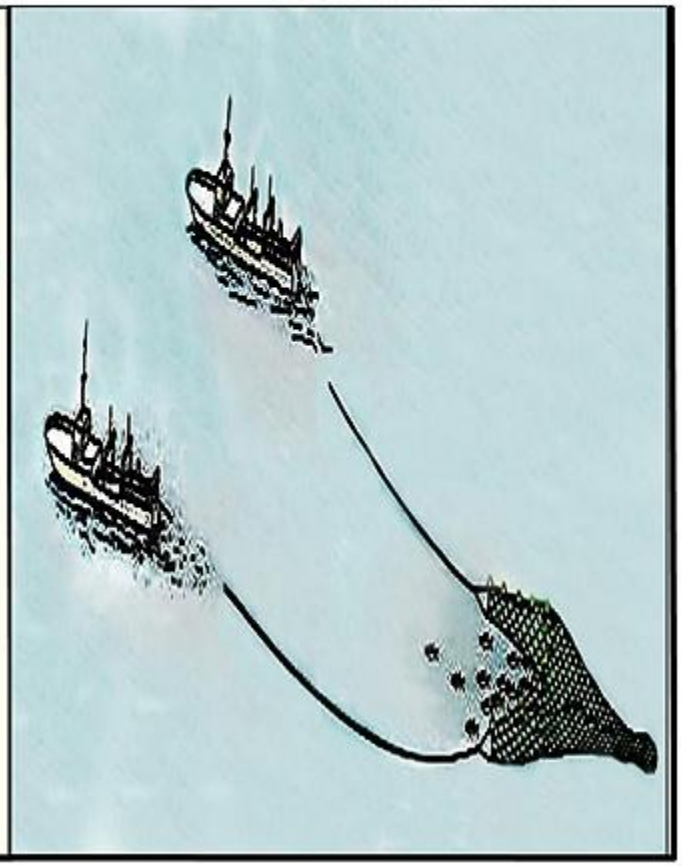
❑ 수거작전 Operation

- ❍ 그물코 : 5mm
  Net loop : 5mm
- ❍ 크기 : 폭 25m, 높이 15m, 길이 60m (5t)
  Size : 25m wide, 15m high, 60m long (5t)
- ❍ 제작기간 : 4. 21~ 28 (1주일)
  Manufacture : 21~28 Apr. (1 week)
- ❍ 운용선박 : 135톤 2척
  Operation Ship : two 135ton ships
- ❍ 시험운용 : 5. 3 (외곽지역)
  Test : 3 May (outer region)
- ❍ 수거작전 : 5. 10 ~ 현재
  Operation : 10 May~ Present

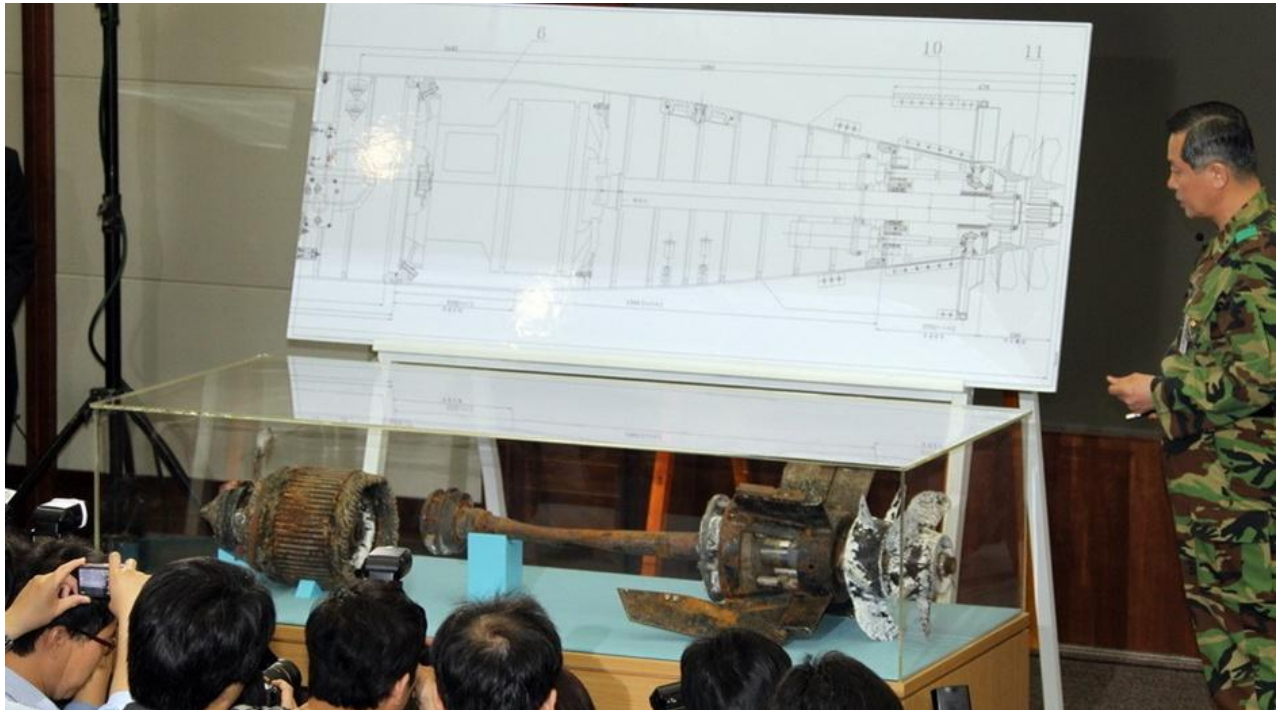
(2) Torpedo Explosion Proof ④: Evidence

- Explosive compounds found on torpedo match that found on Cheonan
- Level of corrosion of torpedo match that of ship
- Discovery location near explosion site

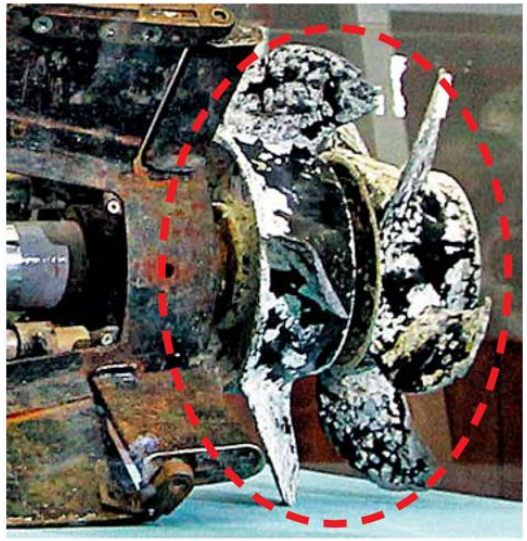
➡ **Retrieved torpedo was responsible for the sinking of Cheonan**

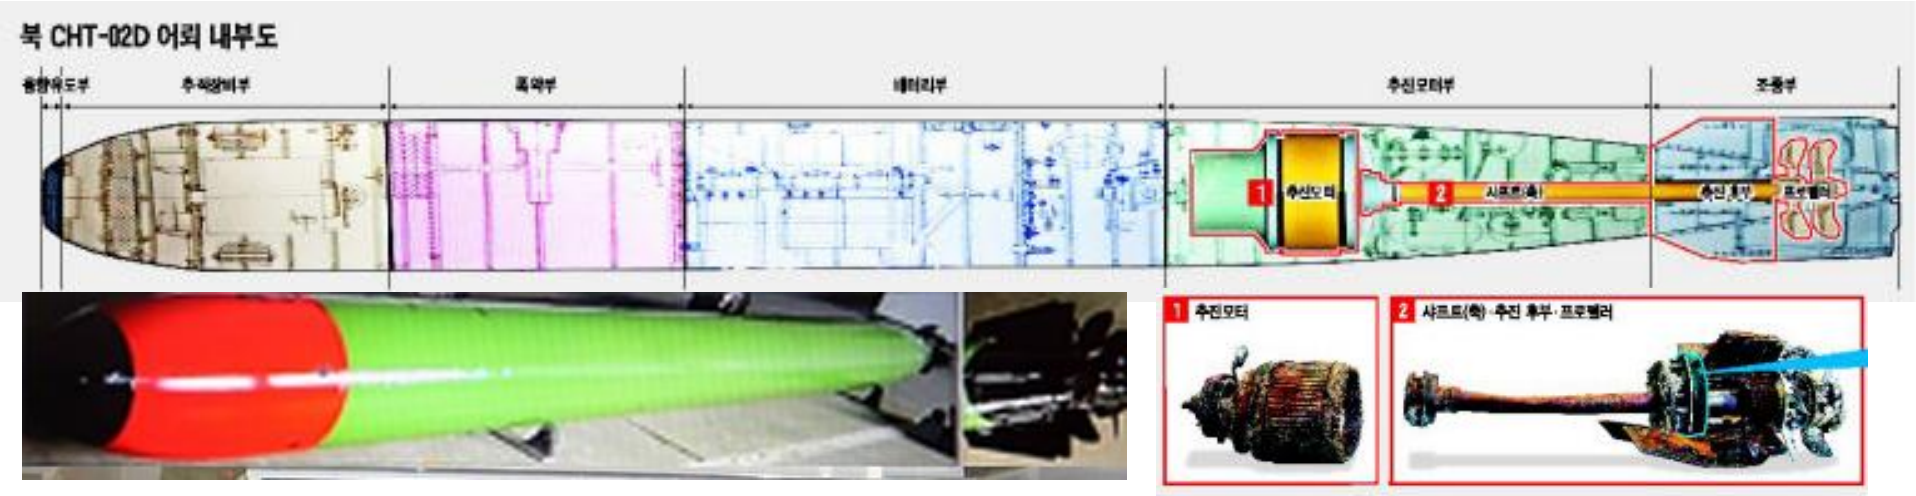
- Parts recovered match NK CHT-02D schematics
  - Schematics found in NK introductory brochure for export purposes

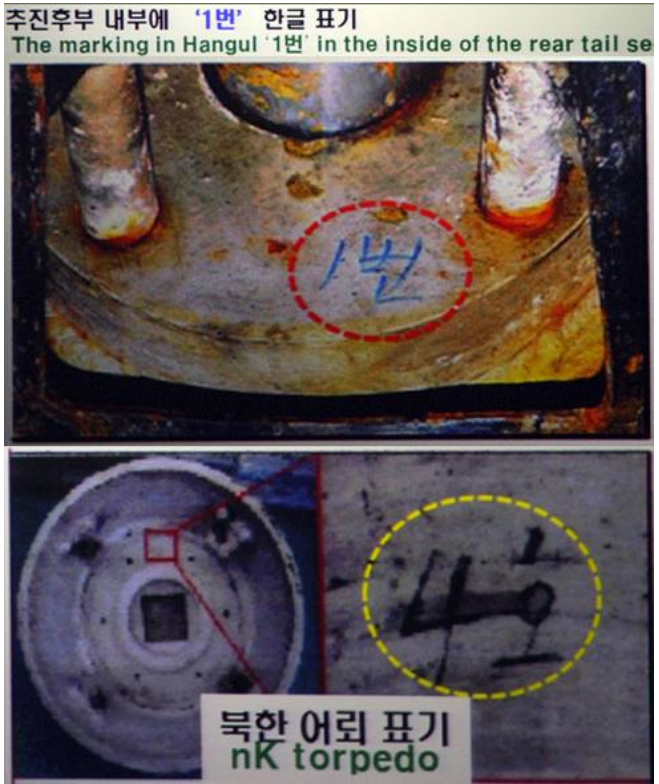
- Markings of Hangul('1번') consistent with marking and pattern with other NK torpedo('4호')
- CHT-02D specs capable of sinking Cheonan
